FERRY SAFETY INVESTIGATION REPORT

PASSENGER FATALITY – *MV LADY ROSE*

SYDNEY HARBOUR, NSW

2 FEBRUARY 2019

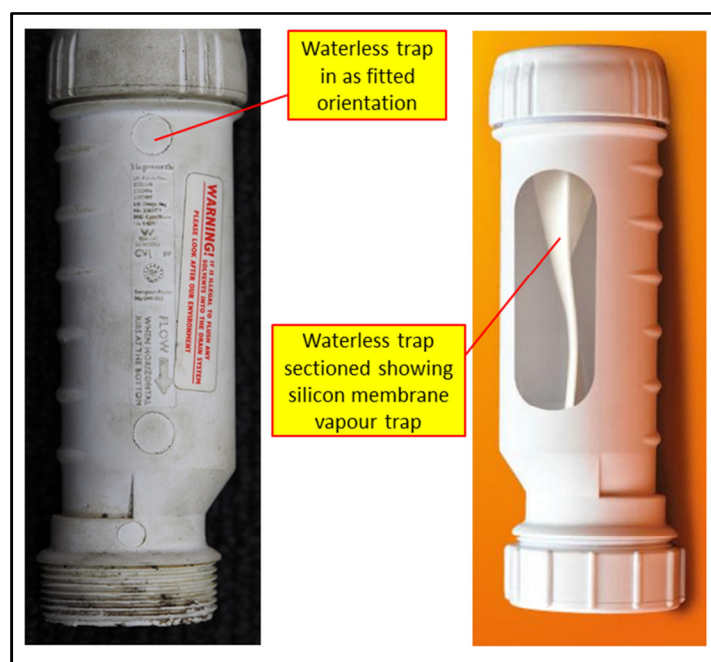
Figure 11: Waterless trap in as fitted orientation

- 2.51 The hand basins in eight of the nine cubicles were fitted with conventional tubular S traps (refer to *Figure 10*). The waste trap fitted to the hand basin in the incident toilet cubicle was known as a waterless trap (refer to *Figure 11*). It was the only toilet fitted with such a trap. It was not known why this trap was different.

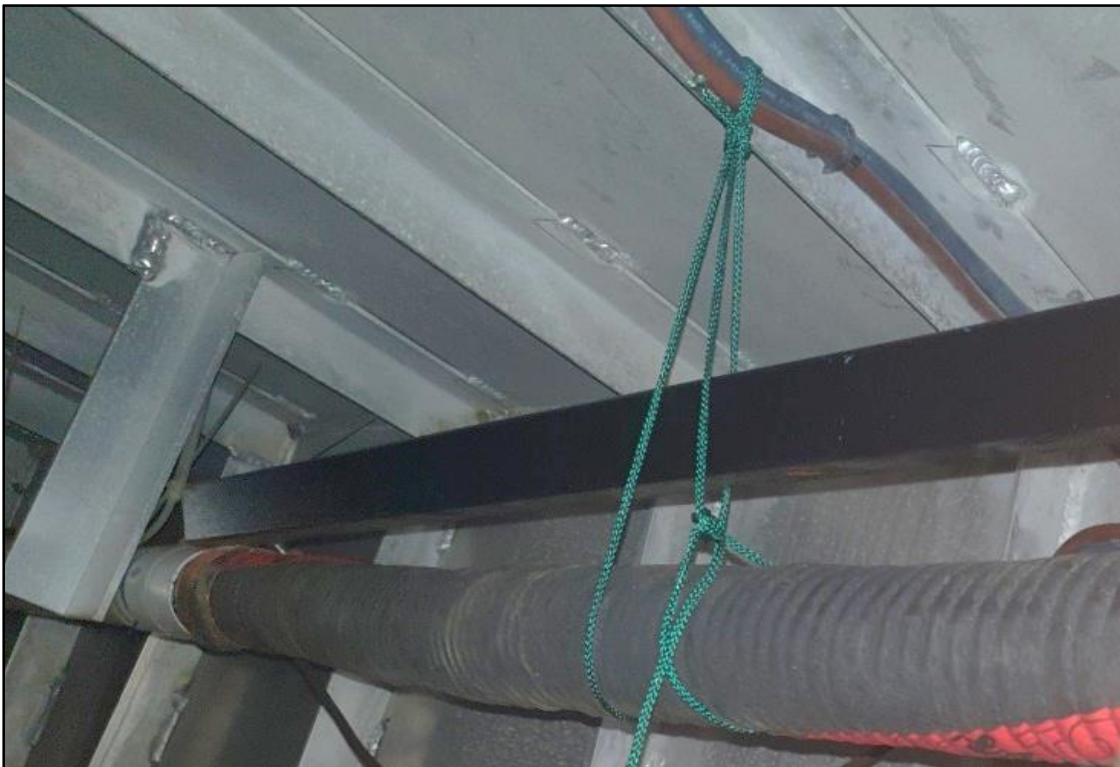
Figure 12: Chord securing rubber hose fitted to vent line

- 2.66 During an inspection of the sewage system, the contracted MAC plumber found that a flexible hose fitted to the horizontal sullage tank vent pipe had sagged approximately equivalent to the outer diameter of the hose. The hose was supported by a piece of cord tied to a bundle of electrical cables above it (refer to *Figure 12*).

- 2.67 The contracted MAC plumber disconnected this length of rubber hose from the vent pipe near the connection to the top of the starboard sullage tank. He noted that a large quantity of effluent was present inside the hose. He was of the opinion that the liquid trapped in the sag in the hose would form a vapour blockage that '*would stop the flow of air*' from the starboard tank, through the vent pipe and to the mast head vent to atmosphere.

fitted to the vent line were; *'Adequate clamping and support of flexible piping systems is required to prevent sagging of flexible piping elements and to ensure adequate fall is provided on the flexible piping, which may otherwise impede the proper operation of the sanitary plumbing system if adequate support is not provided'*.

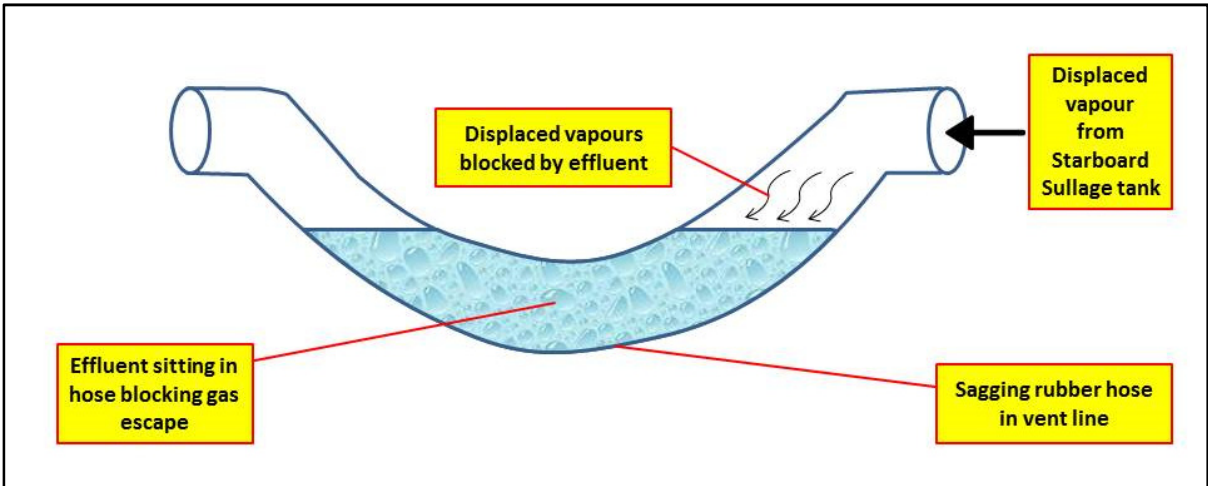
Figure 14: Vapour lock caused by sagging vent line

- 2.69 It is likely that the liquid observed within the rubber hose originated from the port sullage tank due to the tank overflowing from the faulty cistern valve. With the inflow of liquid from the port tank via the vent line and the starboard toilets and galley, it is likely that the available air space in the starboard tank was reduced. As the normal pathway for the sewer gases was impeded by the blocked tank vent line, it is likely that sewer gases from the tank were forced into the main starboard sewer network (refer to *Figures 13 and 14*).
