Junta de Investigación de  
Accidentes de Aviación Civil

# Final Report

LQ-CGK / LQ-FJQ

Exp.:088/15

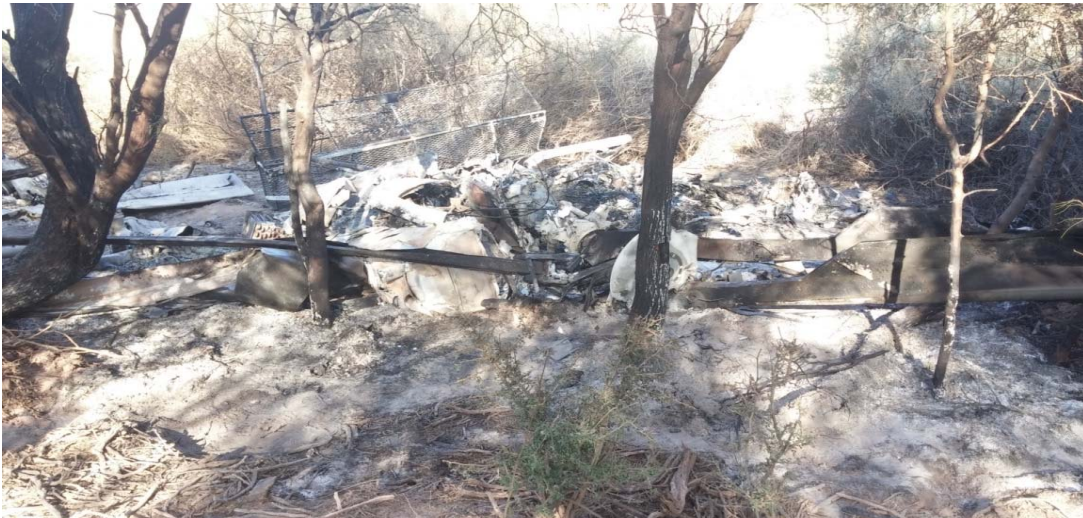
Figure 3. Wreckage of the aircraft LQ-CGK

- Airframe destroyed.
- Engine destroyed.
- Main rotor and blades destroyed.
- Tail rotor and blades destroyed.
- Damage in general classified as “D” (destroyed).

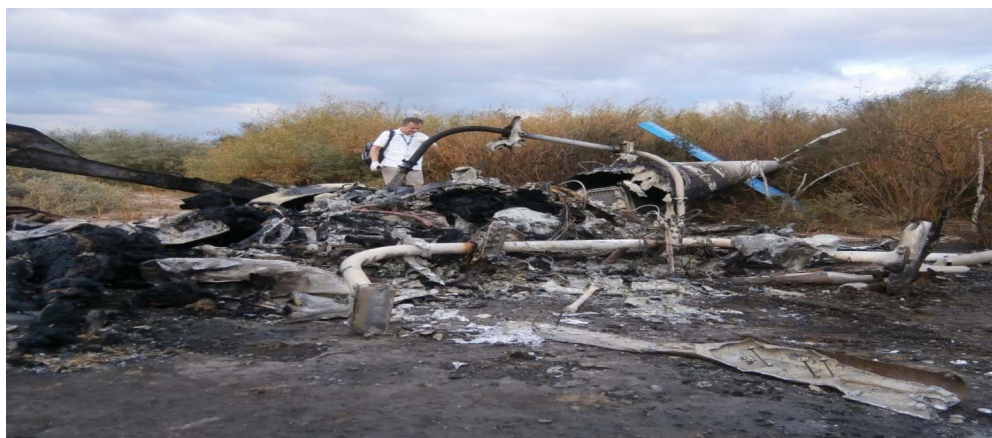
Figure 4. Wreckage of the aircraft LQ-FJQ

- Airframe destroyed.
- Engine destroyed.
- Main rotor and blades destroyed.
- Tail rotor and blades destroyed.
- Damage in general classified as “D” (destroyed).

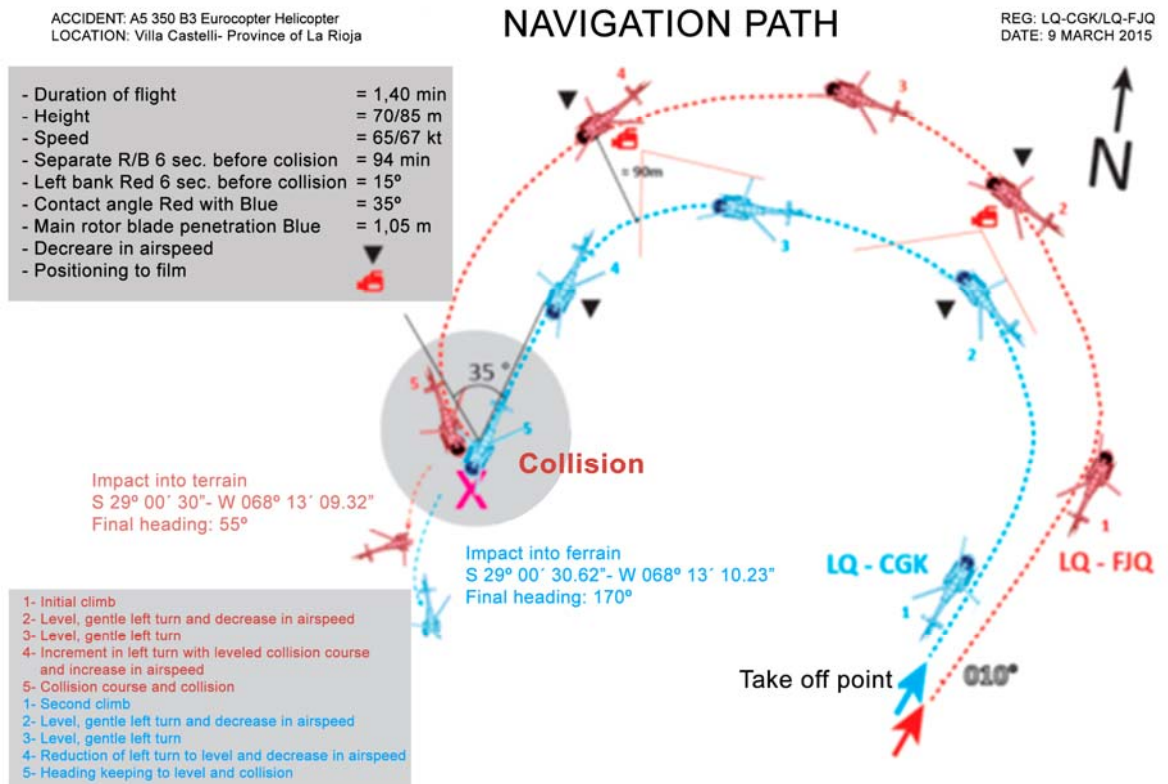
Figure 10. Estimated flight path of the helicopters

After about 94 seconds of flight, LQ-FJQ (Red) increased its bank towards the left in a collision course with LQ-CGK (Blue), which at this moment was decreasing the turn-speed relation.

After about 100 seconds of flight, LQ-FJQ (Red) crashed LQ-CGK (Blue), both main rotors made contact and both aircrafts plunged to the ground.

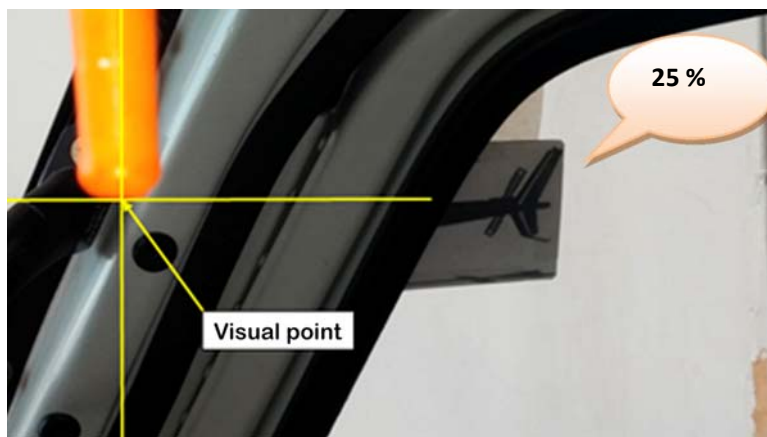
Figure 11. Line of vision from the LQ-CGK pilot's position

After a second the aircrafts were about 25 and 35 m of the collision point and there was a difference of about 20/30 m between the two. In a right angle of about  $70^\circ$ , the LQ-CGK pilot could have seen about 25% of the total surface of LQ-FJQ, since at the direction of his line of vision there was the structure that divides the front right windshield from the right door window.

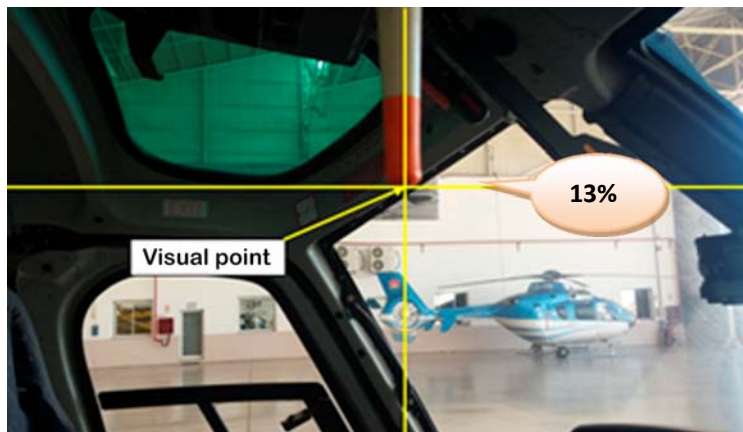
Figure 12. Line of vision from the LQ-FJQ pilot's position

One second before the impact, with a bank of about  $10/15^\circ$  and an angle of about  $70^\circ$  to the left, the LQ-FJQ pilot could have roughly seen a 20% of the totality of the LQ-CGK, since in the line of vision of the pilot's position there was the top front structure, the left windshield and the left door window.

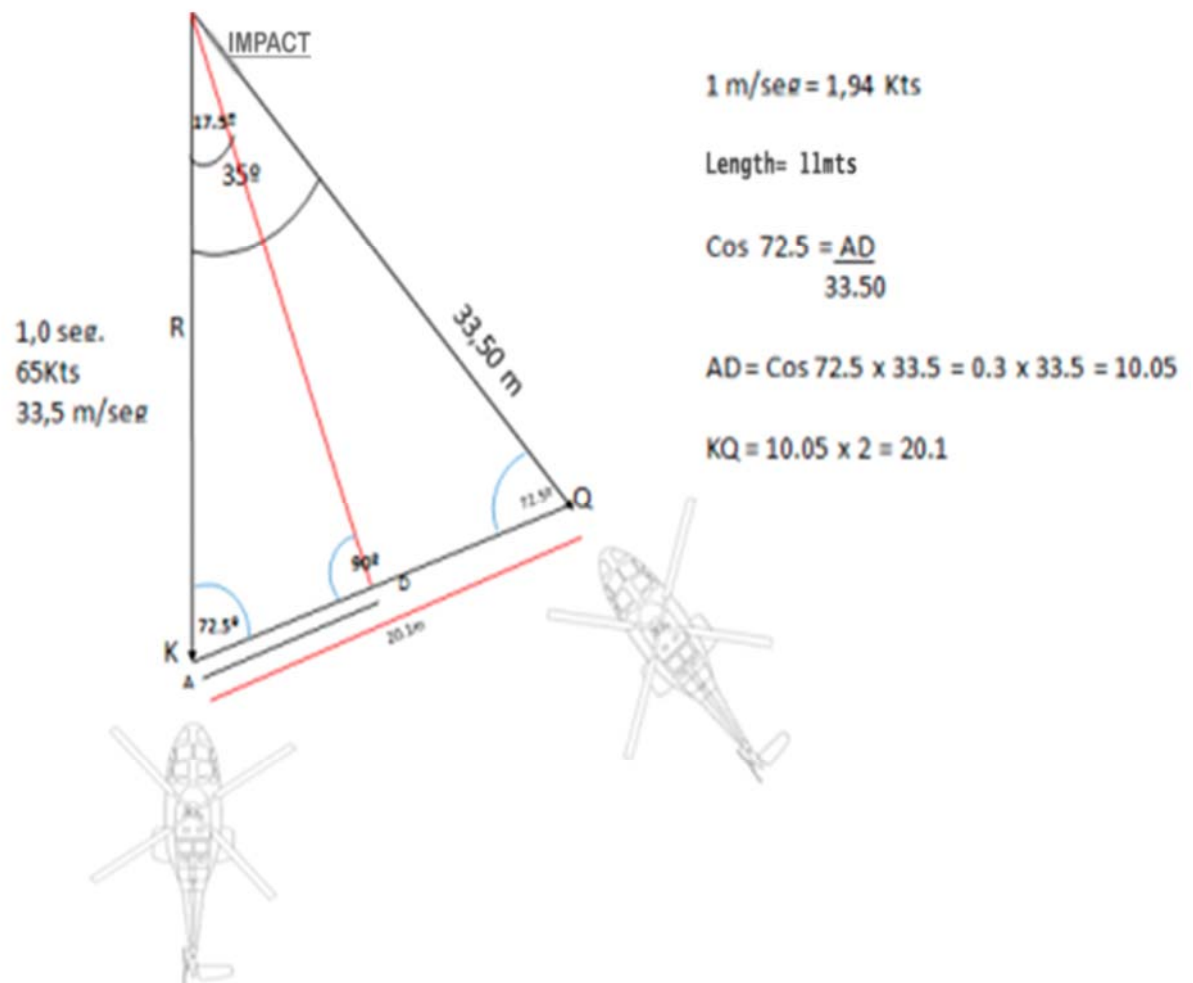
Figure 13. Geometry of the collision

- The relative angle of the vision between both pilots was of about 70°;
- The estimated navigation speed of the aircrafts was between 60 and 70 kt;
- The separation between both aircrafts was between 20 and 30 m;
- The approximate approaching speed between both aircrafts was 20 m/s (40 kt).

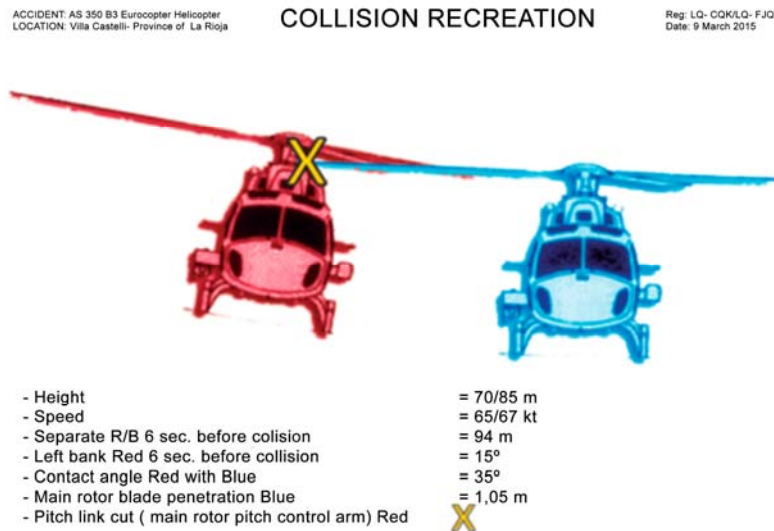
Figure 14. The collision between the helicopters

From filming data it was observed that seconds before the collision there was taper ratio of the LQ-CGK (Blue) main rotor, that cut off one of the control arms of the LQ-FJQ (Red) main rotor pitch. The situation was probably fortunate due to the taper ratio of the LQ-FJQ (Red) main rotor. Both aircraft were left with no collective command and cyclic pitch control since both rotors were mutually damaged by contact.

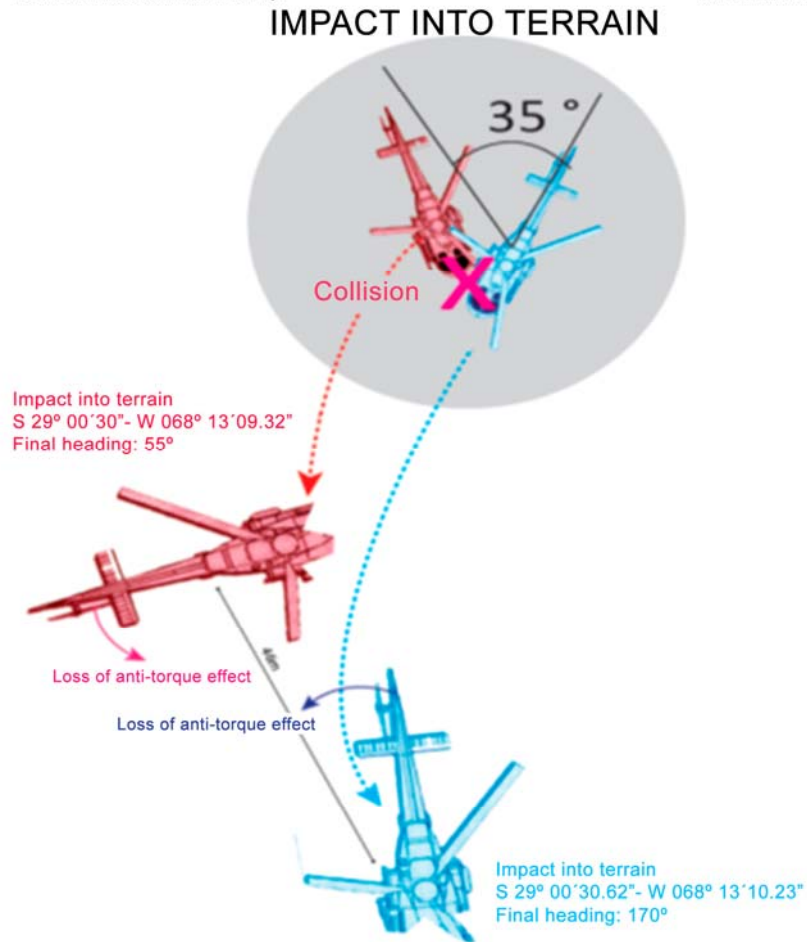
Figure 15. The impact into terrain

The LQ-CGK (Blue) helicopter plunged with a horizontal displacement and fell to the right lateral, impacting into terrain and getting fire. Among the wreckage it was observed that the main rotor blades were cut off by the contact of both main rotors.

Taking into account the approximate heading of the aircrafts at the time of the collision and the final direction of the wreckage in the ground (LQ-FJQ heading 055° and LQ-CGK heading 170°, this variation in the heading of the aircrafts was produced as a result of the yaw towards the west of them caused by the loss of the anti-torque effect.

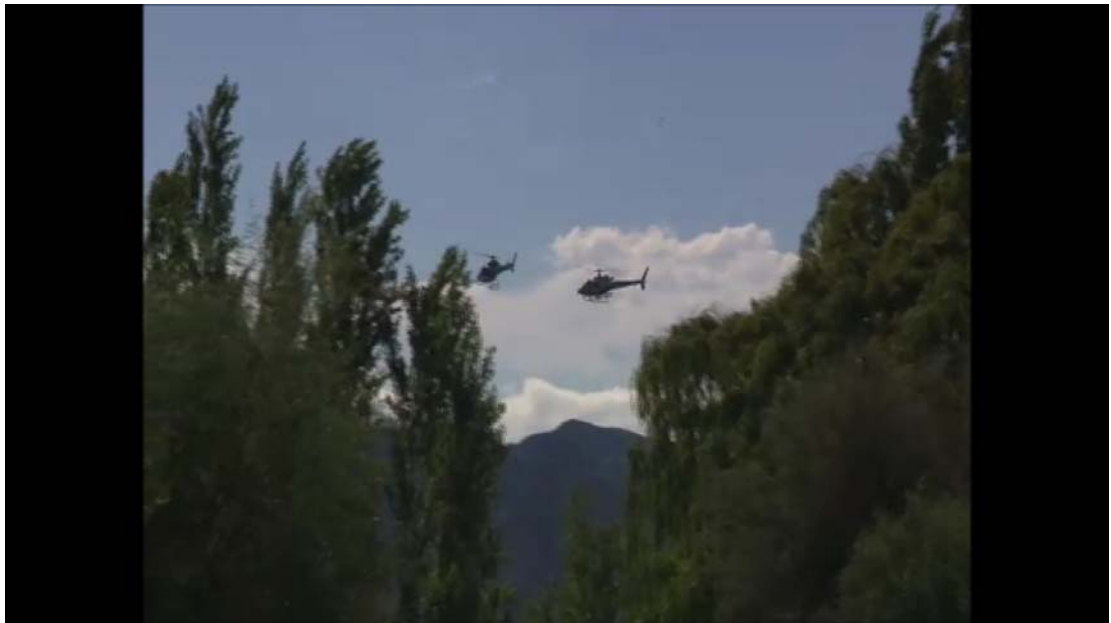
Figure 16. Relative position of the helicopters previous to the collision

During the path previous to the accident, LQ-FJQ reaches LQ-CGK and overtakes it, positioning ahead of it, to the right, slightly over it.

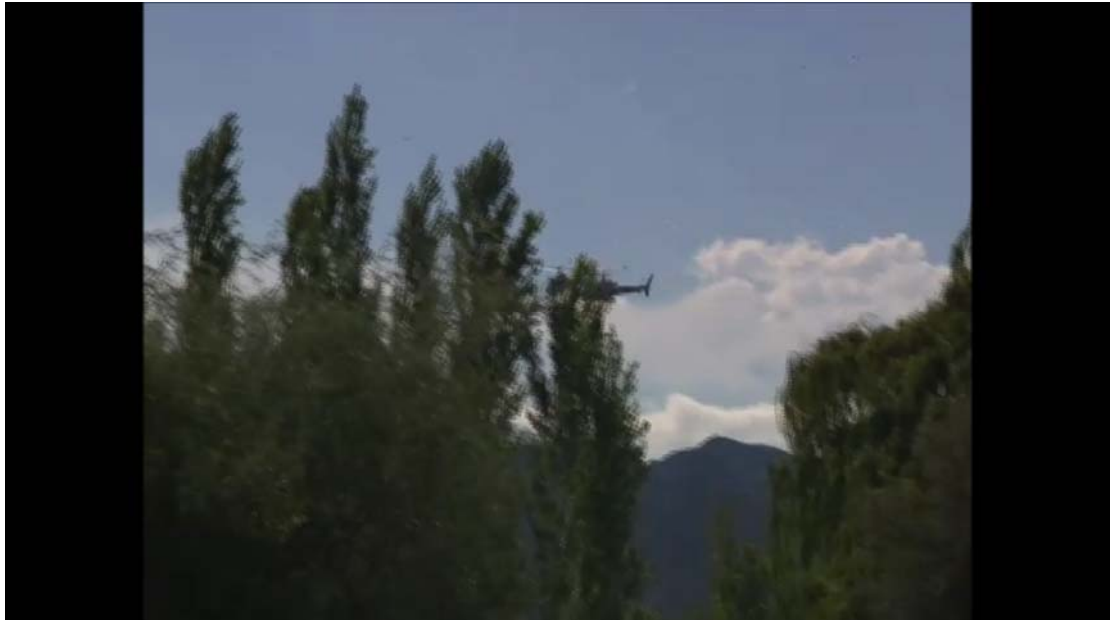
Figure 17. Image of the impact between the helicopters

Finally, LQ-FJQ makes a very slight turn, slightly yawing (with the right pedal), and with a low descent, which reduces significantly the separation in relation to the LQ-CGK path. This provokes the impact of one of LQ-CGK's blades against one of LQ-FJQ's pitch controls. This resulted in the pilots losing control of the aircrafts and plunging to the ground without control.

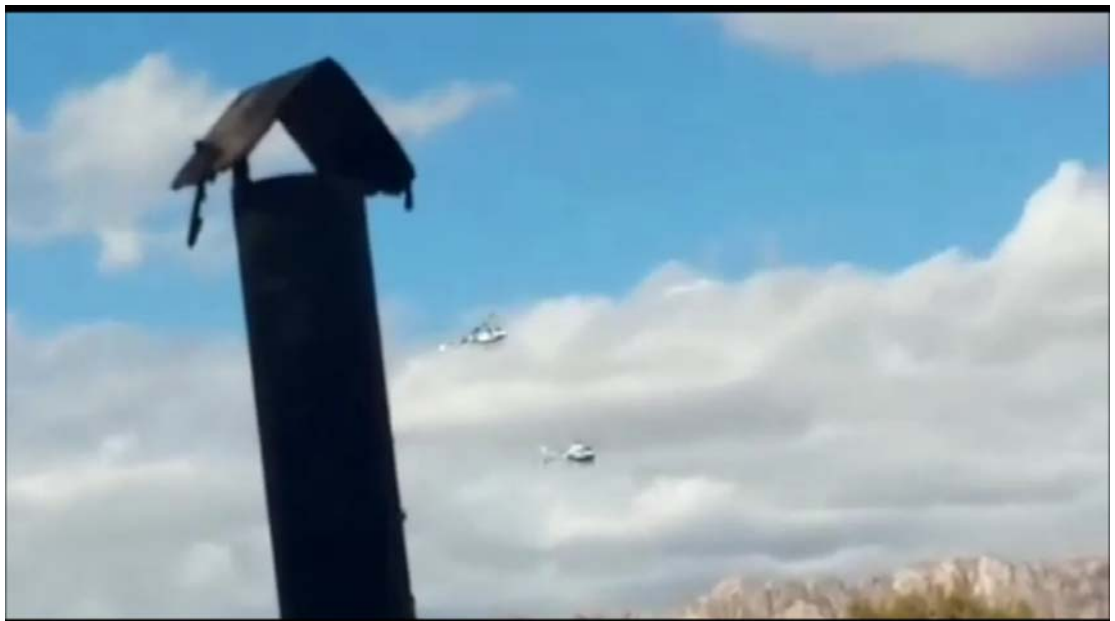
Figure 18. Image of video B

It can be observed that the attitude (position) of the helicopters is not parallel in the video. The causes of this can be: that the aircraft paths are convergent, or that one of the two helicopters has deliberately kept a yaw.

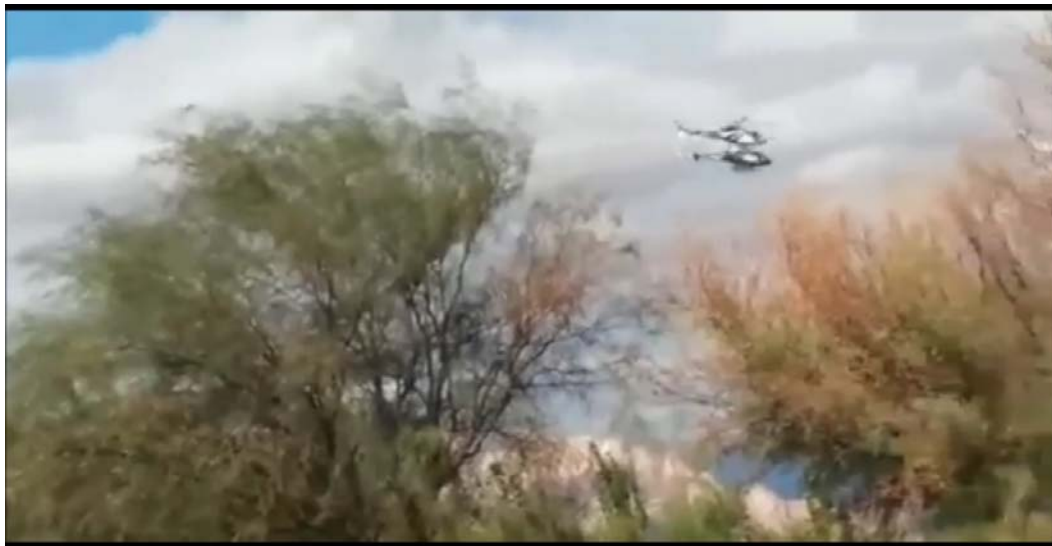
Figure 19. Image of the impact from another position

At the moment of the crash, the fuselage shadow of LQ-FJQ turns completely dark, because LQ-CGK fuselage is blocking the sunlight.

It can be observed in both videos that none of the aircrafts performs evasive or defensive maneuvers before the collision, which indicates a deficit in the visual acquisition of the other aircraft by both pilots.
