FERRY SAFETY INVESTIGATION REPORT

PASSENGER FATALITY – *MV LADY ROSE*

SYDNEY HARBOUR, NSW

2 FEBRUARY 2019

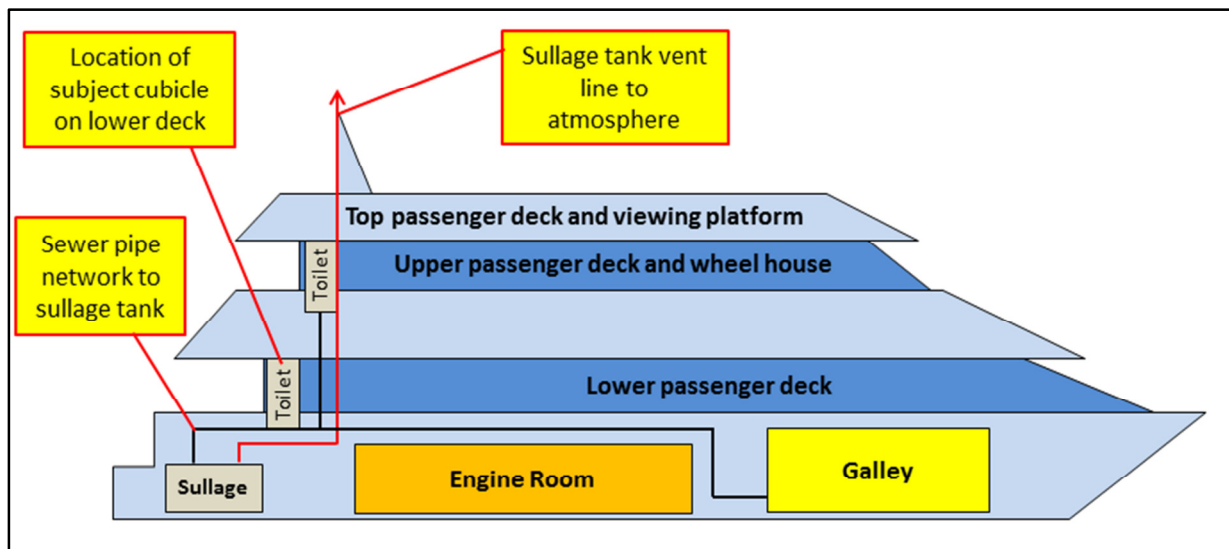
Figure 4: Side elevation showing basic layout of *Lady Rose*

- 1.18 The toilets, basins and floor wastes emptied into two sullage tanks via a network of vapour traps and sewer pipes. The sullage tanks are located below decks in the aft lazarette⁸ and vent to atmosphere via a pipe that runs through the three decks to the masthead (refer to *Figure 4*).
- 1.19 Waste from the starboard and port galley areas pass through a grease separator prior to entering two 100 litre grey water tanks that then feed via two submersible pumps into the corresponding sullage tanks.

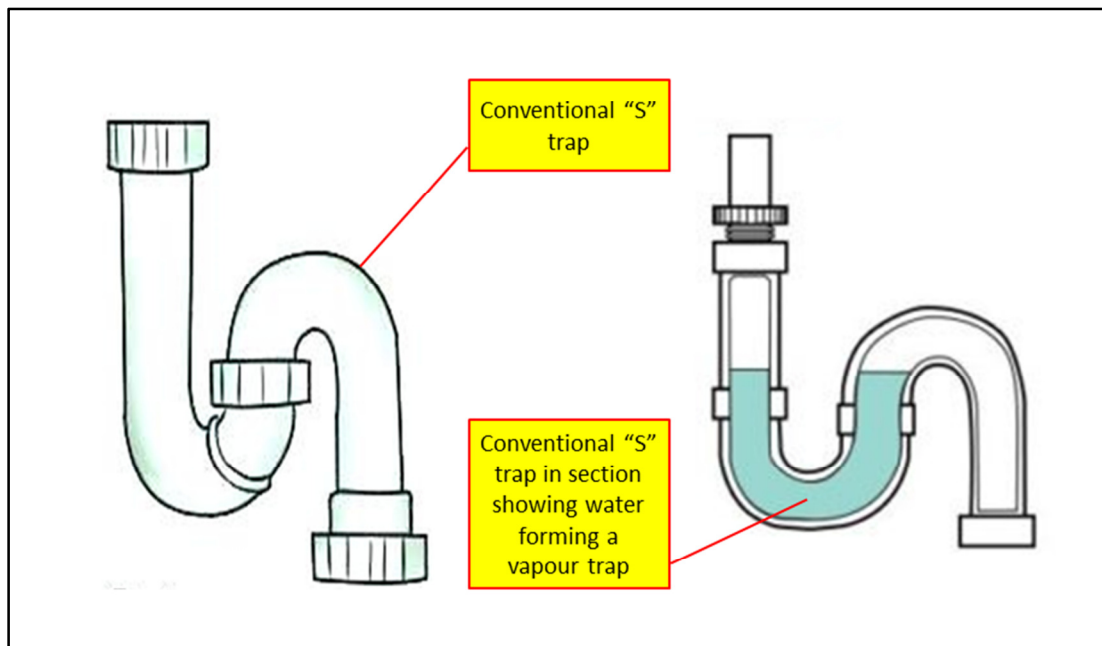
Figure 10: Conventional S traps schematic

- 2.51 The hand basins in eight of the nine cubicles were fitted with conventional tubular S traps (refer to *Figure 10*). The waste trap fitted to the hand basin in the incident toilet cubicle was known as a waterless trap (refer to *Figure 11*). It was the only toilet fitted with such a trap. It was not known why this trap was different.

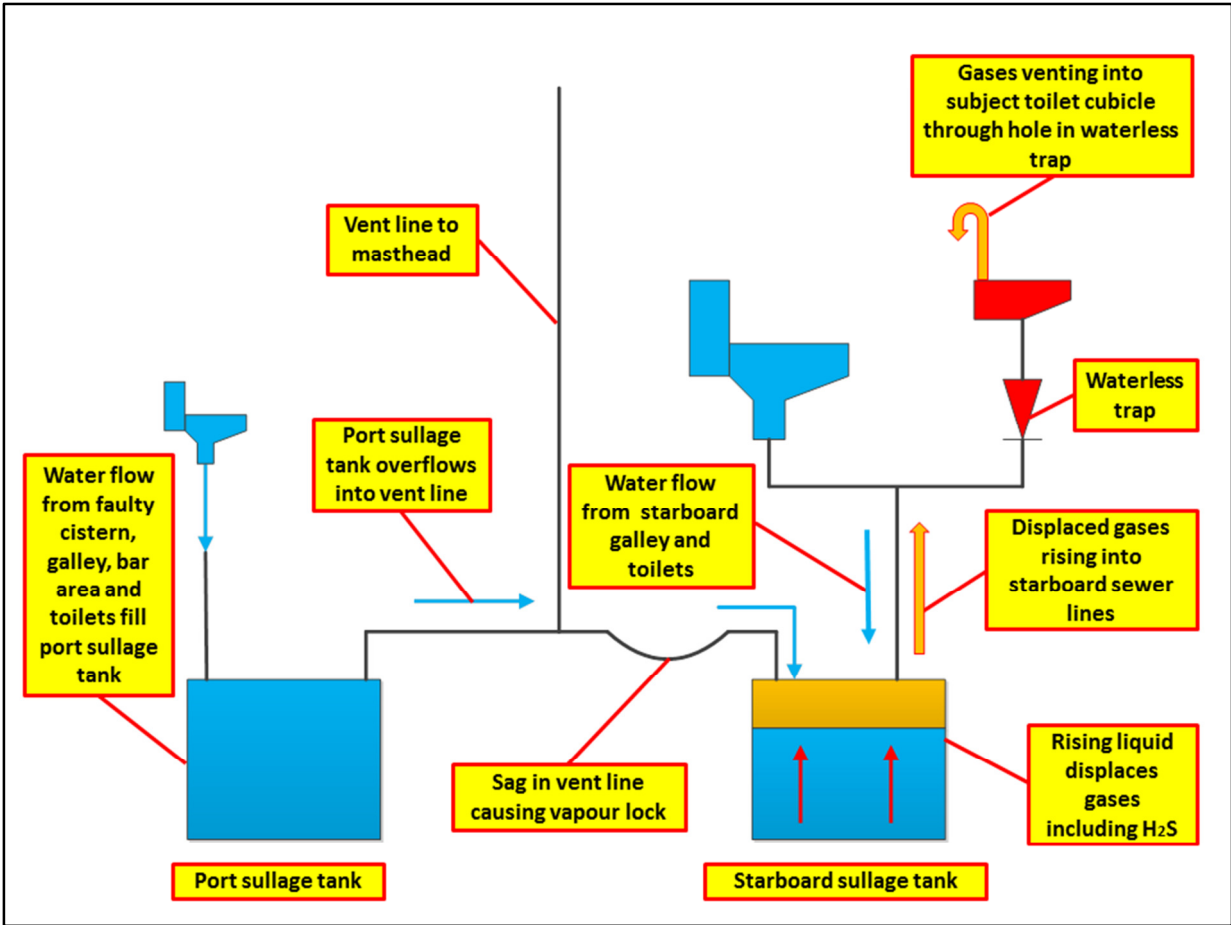
Figure 13: Simplified sewage system diagram

- 2.69 It is likely that the liquid observed within the rubber hose originated from the port sullage tank due to the tank overflowing from the faulty cistern valve. With the inflow of liquid from the port tank via the vent line and the starboard toilets and galley, it is likely that the available air space in the starboard tank was reduced. As the normal pathway for the sewer gases was impeded by the blocked tank vent line, it is likely that sewer gases from the tank were forced into the main starboard sewer network (refer to *Figures 13 and 14*).

- 2.77 The schematic in *Figure 19* shows a simple land-based layout for the venting of sewer gases and the inlet of fresh air to avoid displacement of water in S type water traps. When compared to the schematic in *Figures 9 and 13*, the system on board *Lady Rose* lacked the ability to vent gases from within the sewer line system. The configuration of the starboard side system did not allow air into these lines to avoid possible depletion of water from within S type traps when toilets are flushed.
