Norfolk Island ditching.

The data provided was gleaned as part of our research to assist Ms. Casey in her efforts to provide a considered opinion of the second Australian Air Transport Safety Bureau (ATSB) report into the ditching of a 'medi-vac' jet aircraft off Norfolk Island in 2009, in which Ms. Casey was the attending Flight Nurse.

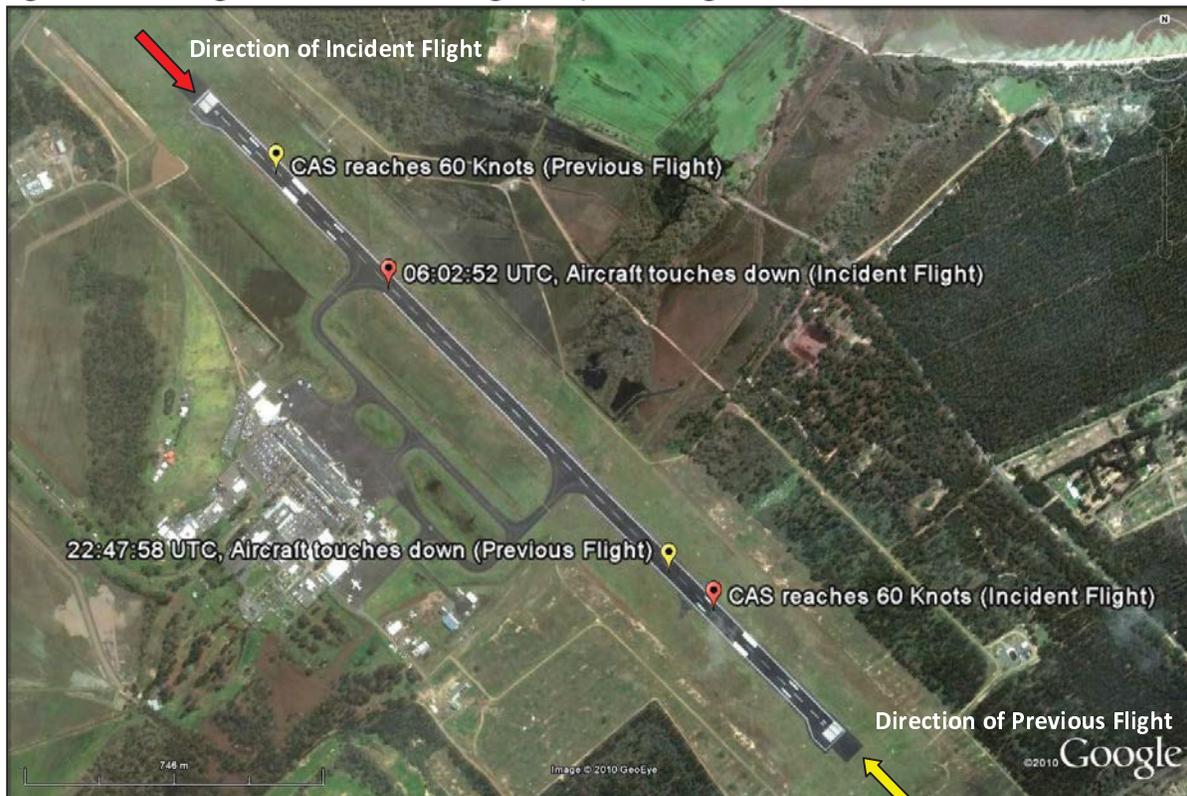
Figure 1: Landing distance for incident flight and previous flight into Hobart

Flight data from a previous flight into Hobart was also examined. The flight had occurred the previous day, when the aircraft had landed on runway 30. The conditions on the day were dry with the data indicating a tailwind of about 3.5 kts. On that flight, the aircraft touched down at 590 m (1,900 ft) and the CAS had reduced to 60 kts at 1,980 m (6,500 ft) (Figure 1).
