ATSB TRANSPORT SAFETY REPORT
Aviation Research and Analysis Report – AR-2008-018(1)
Final

Runway excursions

Part 1: A worldwide review of commercial jet aircraft runway excursions

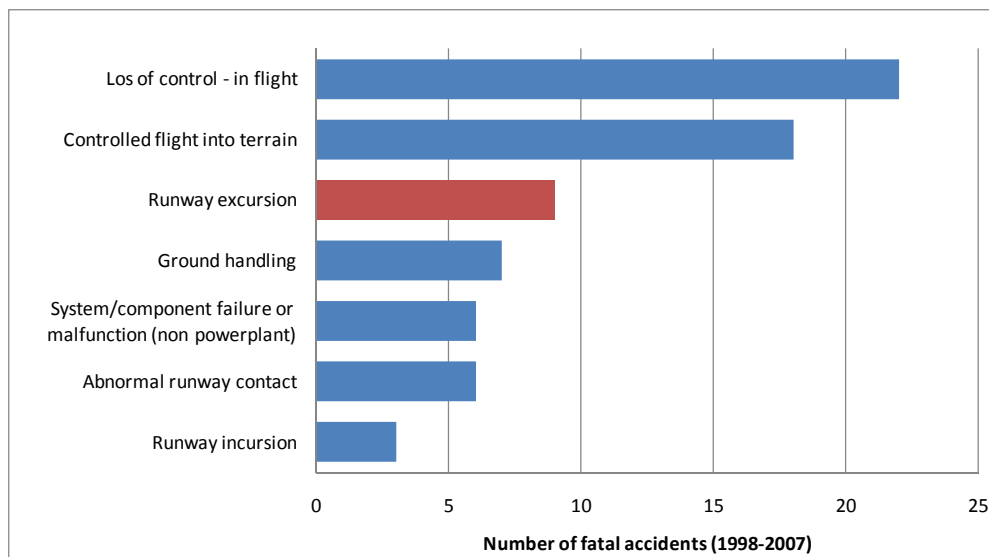
Figure 1: Number of fatal accidents for the worldwide commercial jet fleet, 1998 to 2007, by occurrence category as assigned by the Commercial Aviation Safety Team (CAST)

Runway excursions are the third most frequent fatal accident type for worldwide commercial jet aircraft and the second most frequent type of fatal ALA, with controlled flight into terrain (CFIT) accounting for the greatest proportion of ALAs (see Figure 1). In terms of the total number of fatalities recorded between 1998 and 2007 for commercial jet aircraft, runway excursion accidents rated fourth highest

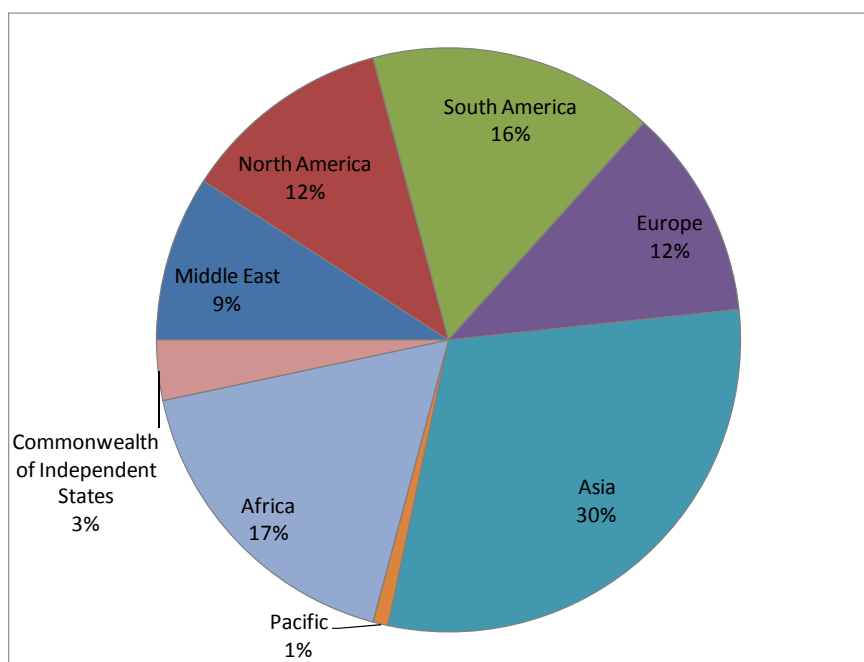
Figure 2: Percentage of runway excursion accidents by continent

- Nine per cent (n = 11) of runway excursion accidents resulted in fatal injuries to flight crew, passengers or bystanders.
- Most excursions occurred in Asia (30 per cent), Africa (17 per cent), and South America (16 per cent) – areas of the world where the overall accident rates are generally lower compared with Australia. In total, these three continents accounted for about two-thirds of all runway excursion accidents between 1998 and 2007 (Figure 2), despite accounting for less than 30 per cent of worldwide aircraft departures (Ranter, 2006).
- The remaining 37 per cent of runway excursion accidents occurred in North America, Europe, the Middle East, the Pacific, and the Commonwealth of Independent States (CIS) - areas of the world where the overall accident rates are generally comparable with Australia.

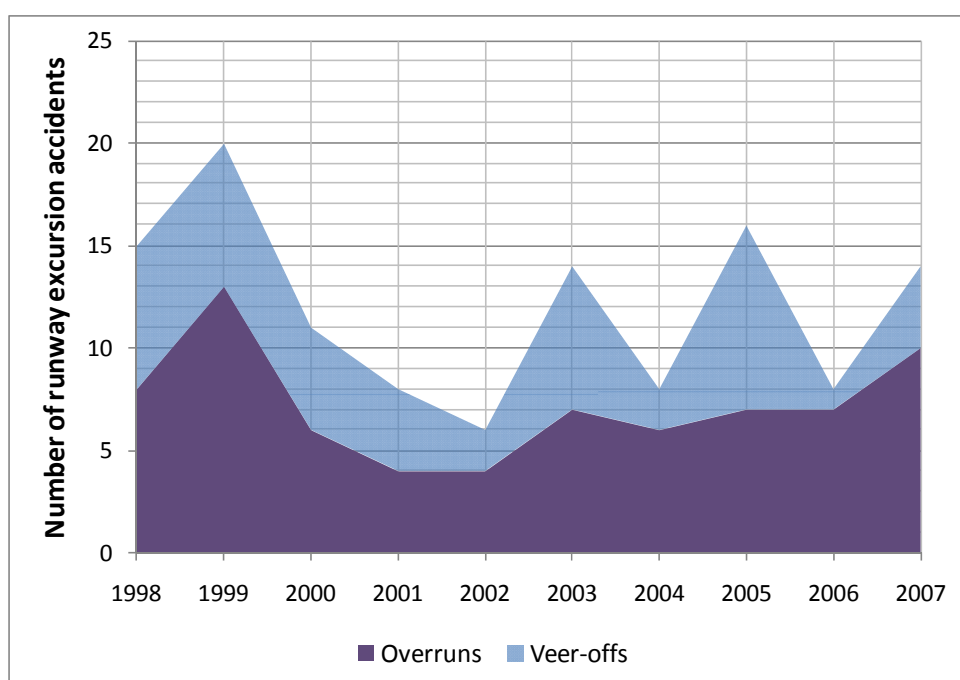
Figure 3: Frequency of runway excursion accidents during landing by type, 1998 to 2007

Over the reporting period, the highest number of runway excursion accidents during landing was recorded in 1999, with 13 overruns and seven veer-offs recorded that involved Western-built commercial jet aircraft. This had consistently declined to six runway excursions by 2002. However, since this time, the numbers have fluctuated across the years, with an average of nine accidents per year for 2003 to 2007 (Figure 3). As a result, the overall average for the decade remained above the long-term National Transportation Safety Board and FAA estimate of 10 per year (FAA, 2007).

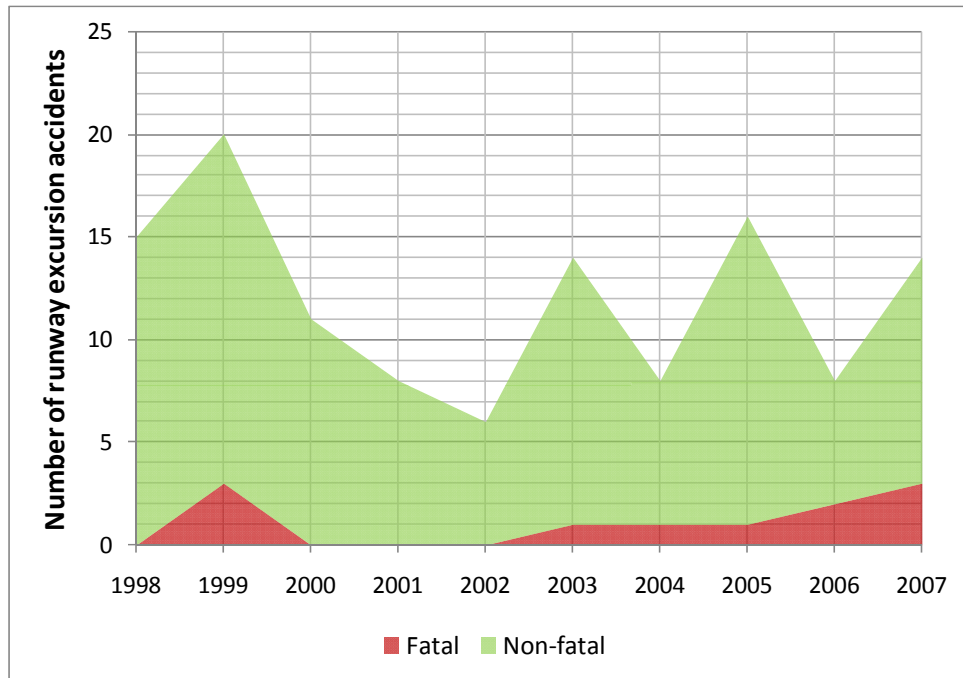
Figure 4: Frequency of runway excursion accidents during landing by outcome, 1998 to 2007

Of the 120 excursion accidents that occurred in the landing phase of flight between 1998 and 2007, 11 resulted in fatalities to the aircraft occupants with a total of 494 people fatally injured (Figure 4). Most of the fatal accidents were overruns (nine fatal accidents resulting in 401 fatal injuries, compared with two fatal veer-offs resulting in 93 fatal injuries). This is slightly lower than estimates by Boeing over the same period of 449 onboard fatalities and 89 fatalities on the ground due to runway excursion accidents (Boeing, 2008).

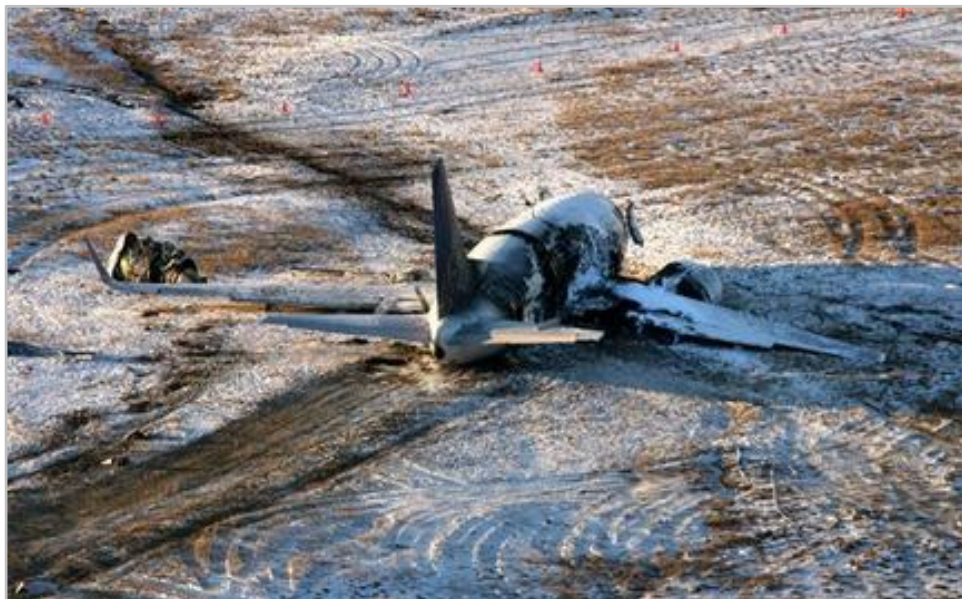
Figure 5: Boeing 737-500 veer-off accident at Denver International Airport, Colorado, 20 December 2008

damage to the fuselage, and a post-impact fire. The runway surface was dry and free from snow at the time of the accident. Of the 115 people on board, 38 sustained injuries with at least two people seriously injured (Figure 5).

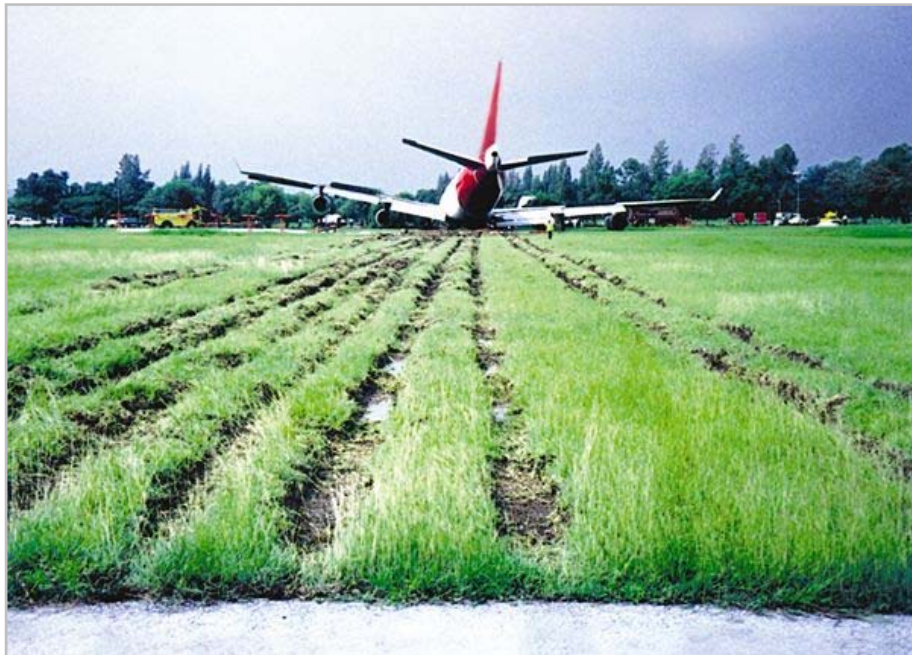
Figure 6: Boeing 747-400 overrun accident at Bangkok International Airport, Thailand, 23 September 1999

an instrument landing system (ILS) localiser antenna that initiated the collapse of the nose and right wing landing gear. This allowed the aircraft to adopt a slight right wing low attitude, resulting in the right inboard and outboard engine nacelles contacting the ground. The aircraft eventually came to rest on a road 220 m from the end of the stopway¹⁴ (Figure 6). None of the three flight crew, 16 cabin crew or 391 passengers reported any serious injuries. The accident was investigated by the ATSB (ATSB, 2001).

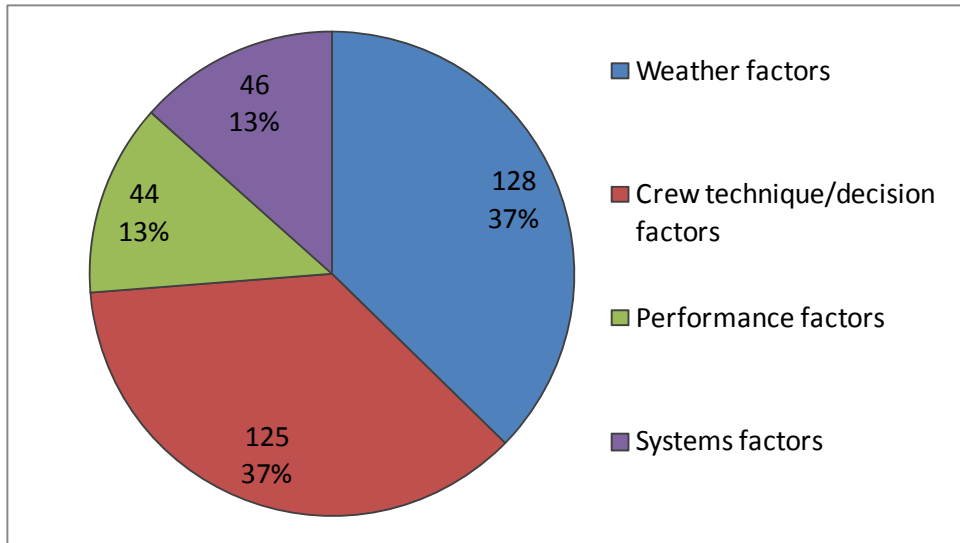
Figure 7: Total number of contributing factors (343) to all runway excursion accidents worldwide during the landing phase of flight, 1998 to 2007

Figure 7 provides a high-level breakdown of the prevalence of these contributing factors in runway excursion accidents. Figure 8 shows the number of accidents that involved at least one contributing factor from the FSF categories.

An analysis of each of these factors is discussed in depth in Chapters 4, 5, 6 and 7. In summary, the categories presented in Figure 7 and Figure 8 included the following:

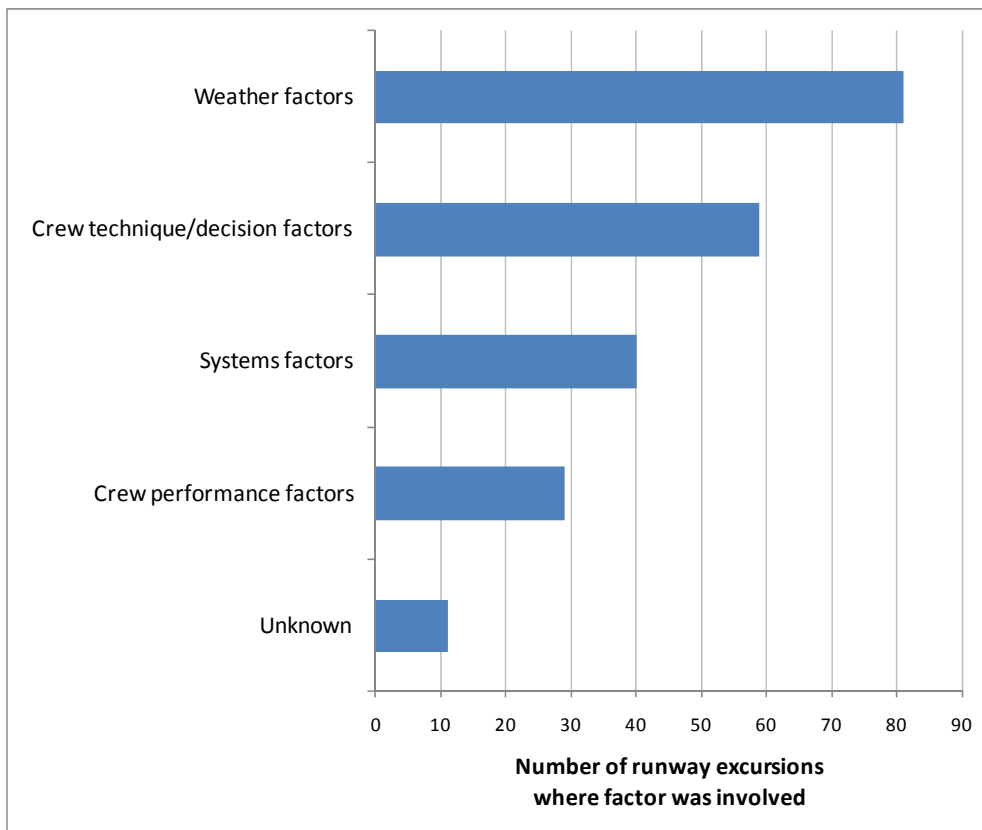
Figure 8: Number of runway excursion accidents worldwide on landing (120) involving at least one contributing factor, 1998 to 2007

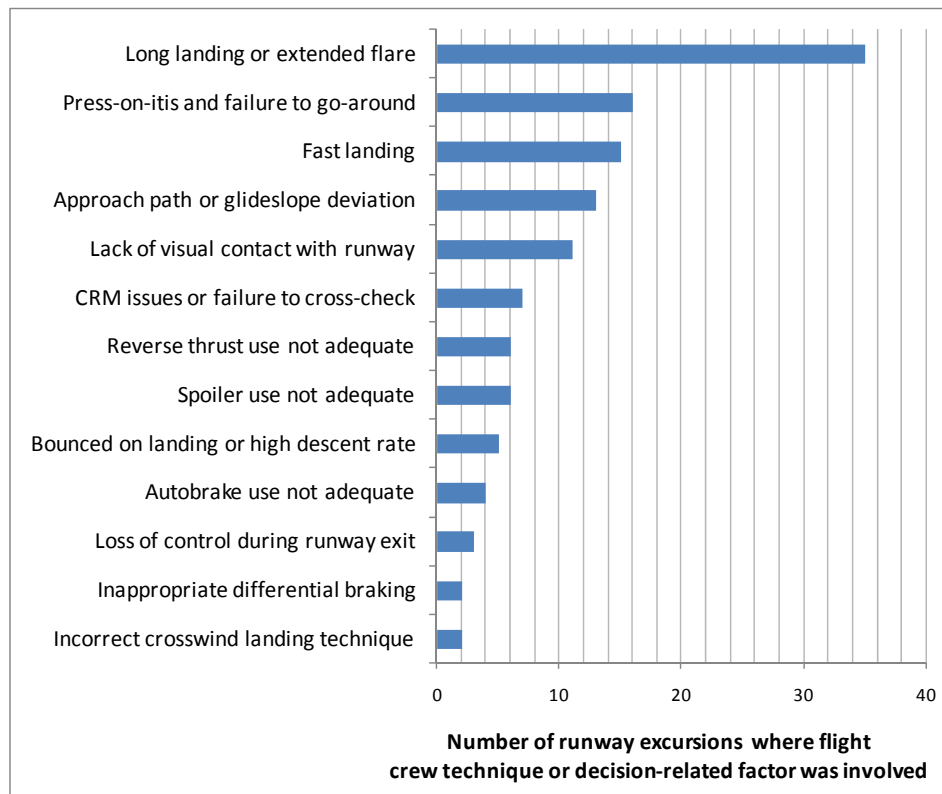
Figure 9: Breakdown of flight crew technique/decision-related factors across 59 runway excursions on landing, 1998 to 2007

Figure 9 presents a breakdown of the frequency of different types of flight crew technique/decision-related factors identified. The five most were:

- a long landing or extended flare;
- a decision to press on with an unstabilised approach and not conduct a go-around or diversion to another airport;
- a fast landing above the aircraft's approach reference speed (V_{ref});
- a deviation from the approach path or glideslope during final approach (resulting in an unstabilised approach); and
- less than adequate or intermittent visual contact with the runway on final approach and landing, often leading to a loss of spatial awareness and a deviation from stabilised approach parameters.

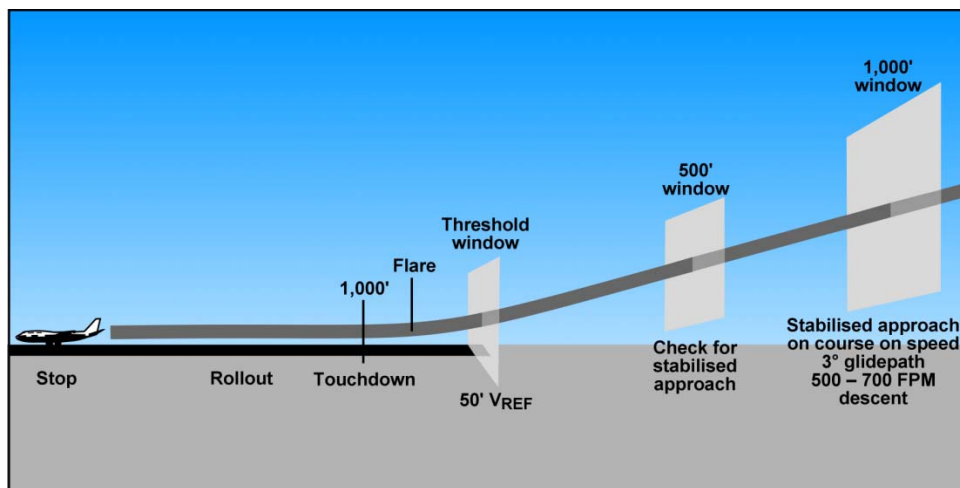
Figure 10: Aspects of a stabilised approach

Figure 10 depicts the aspects of a stabilised approach. The approach should be stabilised at 1,000 ft in IMC conditions or 500 ft for VMC conditions. The aircraft should be at a height of approximately 50 ft when crossing the runway threshold, prior to the flare, and landing in the touchdown zone (generally 1,000 ft beyond the threshold).

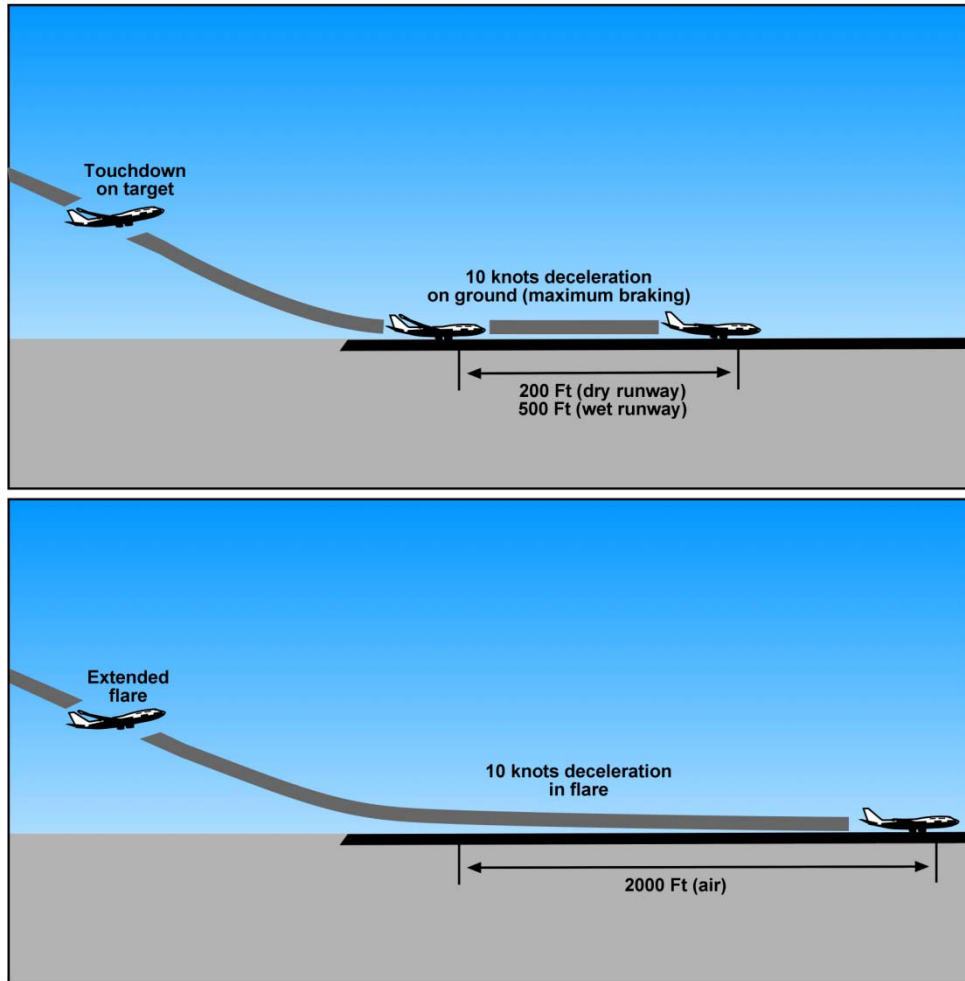
Figure 11: Effect of an extended flare on landing distance

However, extended flares can result in long landings, significantly reducing the available runway length for landing. An extended flare typically uses up *hundreds or thousands of feet* – 2,500 ft (760 m) per every additional 10 kts according to FAA data (Figure 11). As a result, they frequently play a part in overruns. For example, a five per cent increase in the final approach speed above V_{ref} increases the landing distance by:

- 10 per cent if a normal flare and touchdown are conducted, and the excess airspeed is lost by decelerating the aircraft on the ground (300 ft increase per every 10 kts above V_{ref}); and
- 30 per cent if an extended flare is conducted, and the excess airspeed is bled off by floating (FAA, 2007; FSF, 2000c).

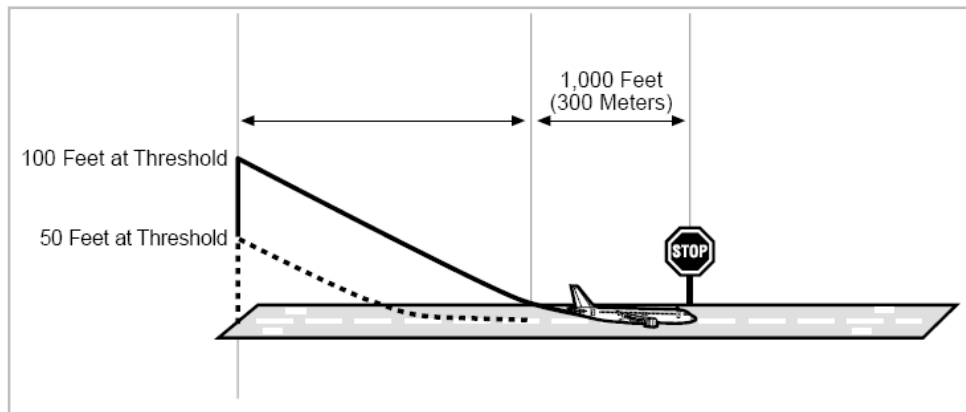
Figure 12: Effect of threshold crossing height (TCH) on landing distance

Crossing the threshold point slightly higher than the normal TCH has similar effects on the landing distance (Figure 12). Every increase of 10 ft (3 m) in TCH adds a possible 200 ft (61 m) to the landing distance (FAA, 2007).

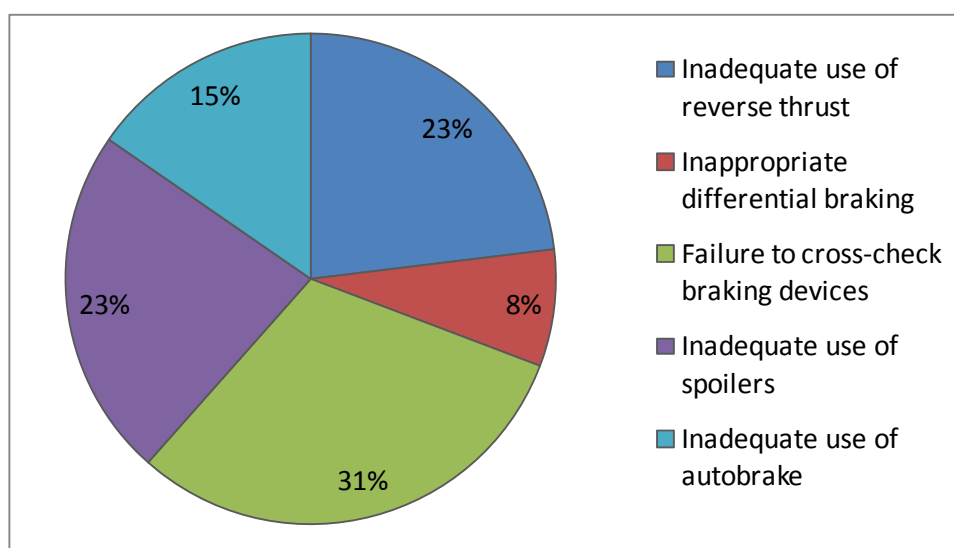
Figure 13: Breakdown of flight crew technique/decision-related delayed braking and flight crew actions across 17 landing excursion accidents, 1998 to 2007

In terms of crew technique or decision-related factors, 20 per cent of those factors were related to delayed braking and flight crew actions. Within this proportion (involving 17 individual accidents), inadequate cross-checking between flight crew members to ensure that braking devices were properly armed or being applied was the leading contributing factor to excursions (Figure 13). Inadequate use of autobrakes, reverse thrust or spoilers for the prevailing runway conditions and airspeed were also common factors involved in runway excursions. In veer-offs, inappropriate differential braking by the flight crew was involved in a small proportion of accidents.

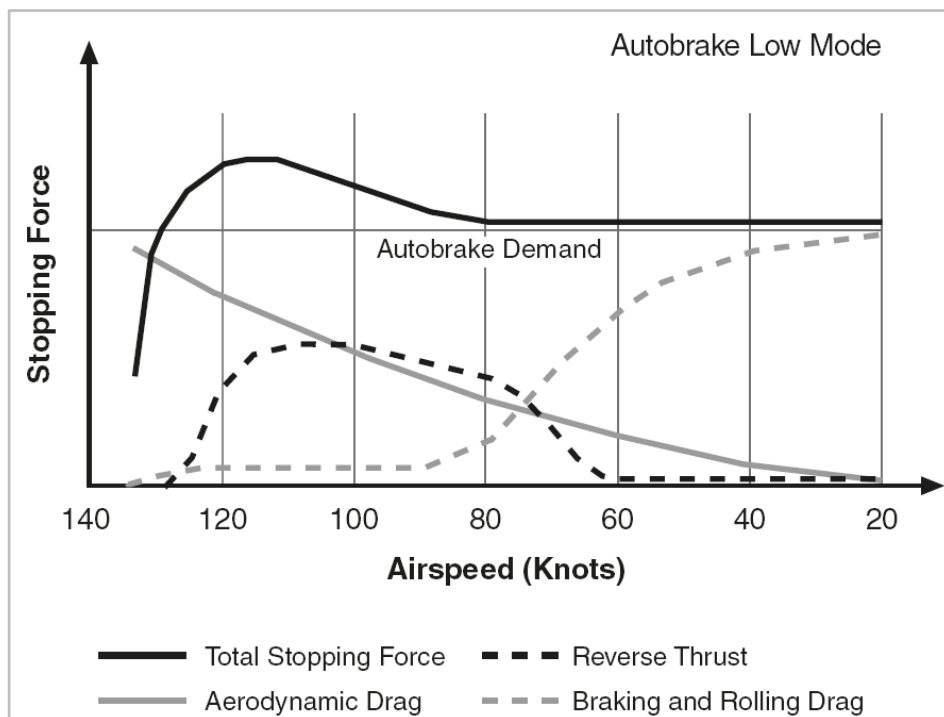
Figure 14: Typical decelerating forces during the landing roll

Figure 14 shows the relative effectiveness of each of these forces at different aircraft speeds during the landing roll. At high ground speeds with the spoilers deployed, aerodynamic drag and reverse thrust provide approximately 50 per cent of the total force to stop the aircraft. At lower speeds, aerodynamic drag and reverse

thrust reduce to about 20 per cent of the stopping capability, with the contribution of wheel braking increasing to provide 80 per cent of the total stopping force (ATSB, 2004).

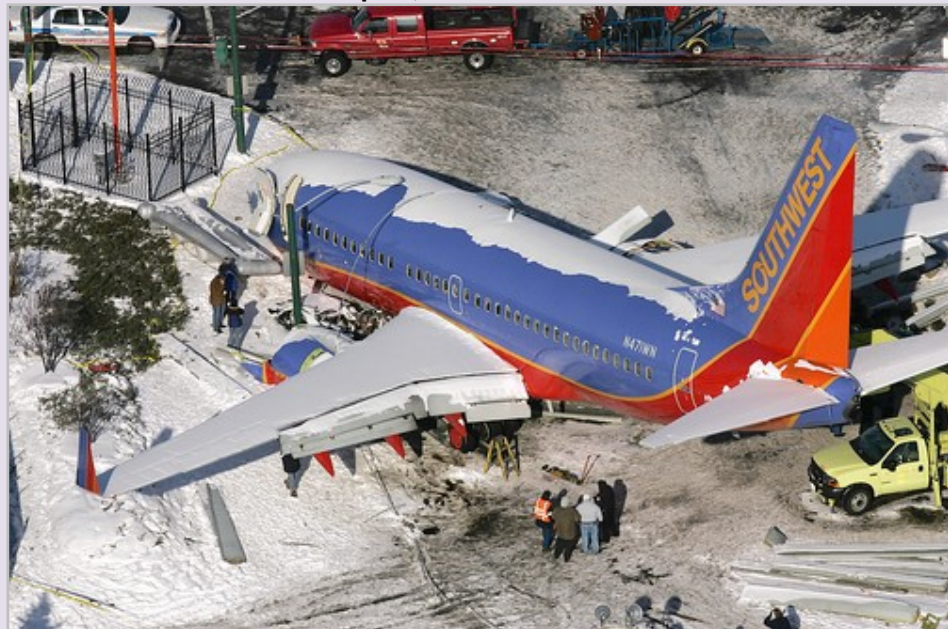
Figure 15: Boeing 737-700 overrun accident, Chicago Midway International Airport, 8 December 2005

The fatal runway overrun accident of a Boeing 737-700 at Chicago Midway International Airport, Illinois on 8 December 2005, highlighted how delayed flight crew actions can combine with poor environmental conditions and a narrow margin for landing errors at inner city airports to produce a tragic outcome.

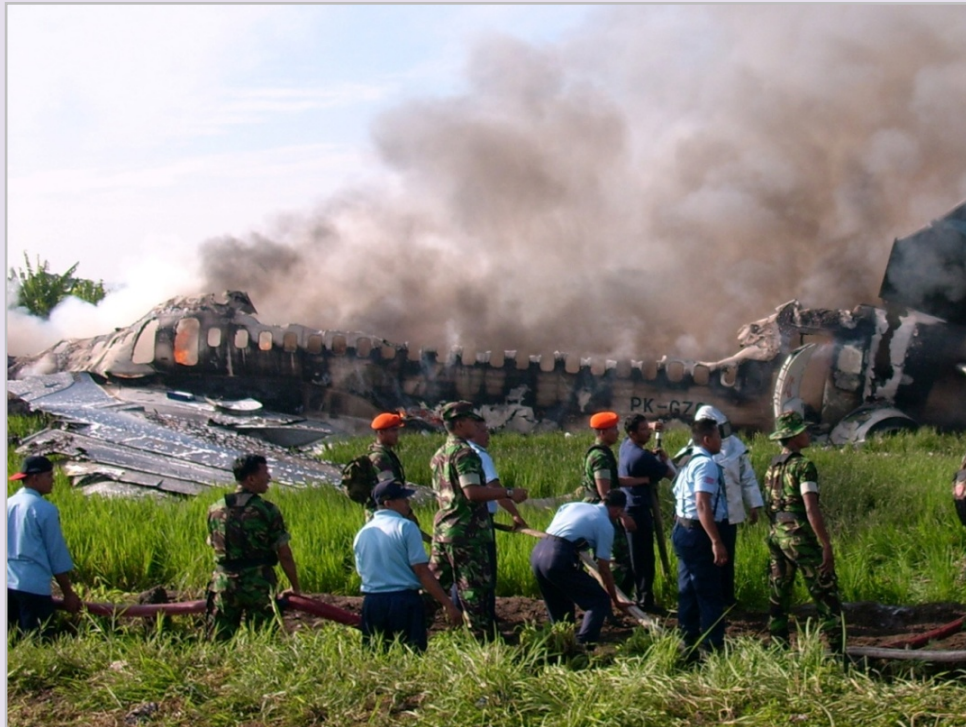
Figure 16: Boeing 737-400 overrun accident, Adisucipto Airport, Yogyakarta, Indonesia, 7 March 2007

The fatal runway overrun accident of a Boeing 737-400 at Yogyakarta, Indonesia on 7 March 2007 highlighted how a combination of flight crew techniques and decisions, such as CRM practices and a decision by the flight crew not to execute a go-around when the aircraft approach was unstabilised, can lead to a runway excursion accident.

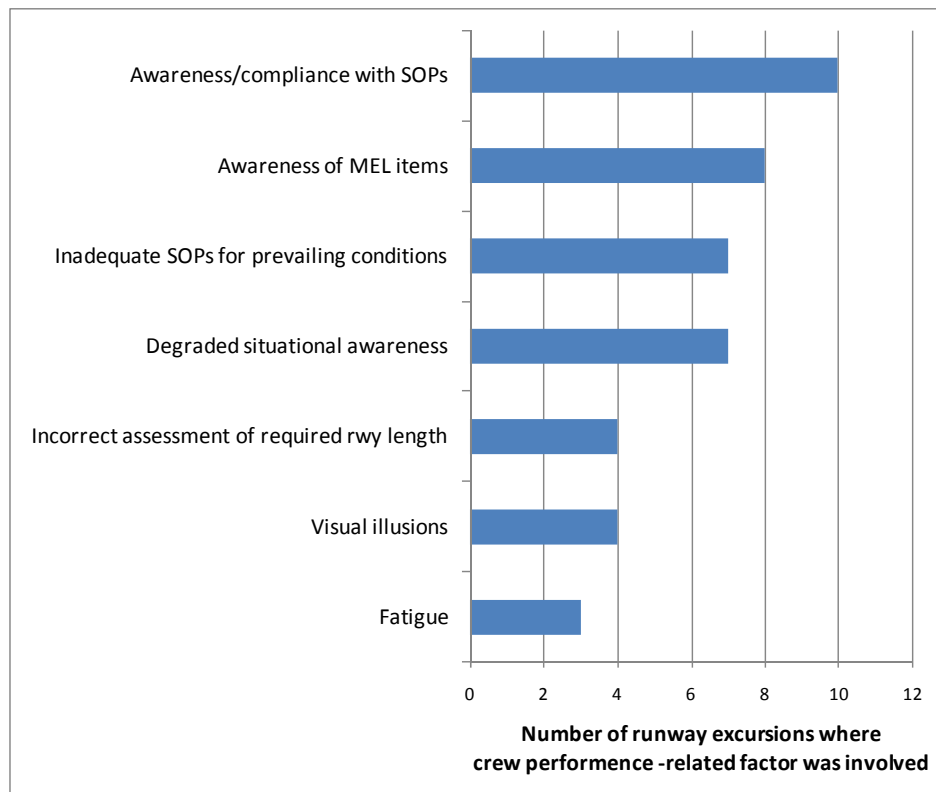
Figure 17: Breakdown of performance-related factors across 29 runway excursions on landing, 1998 to 2007

Figure 17 presents a breakdown of how frequently each type of performance-related factors was involved in the 29 runway excursion accidents (24 per cent) where these types of contributing factors were identified. The five most common performance-related issues were:

- flight crew awareness, training and compliance with standard operating procedures (SOPs) for approaches and landings;
- awareness of unserviceable items listed on the minimum equipment list (MEL), and an assessment of their probable effect on the aircraft's braking performance after touchdown;
- standard operating procedures that provided incorrect, ineffective, or no guidance on how flight crew should approach landings in a range of approach and runway conditions;
- degraded situational awareness, due to stress and task saturation; and
- not conducting an accurate calculation of the required rollout length for the aircraft, taking into consideration the runway conditions and approach type.

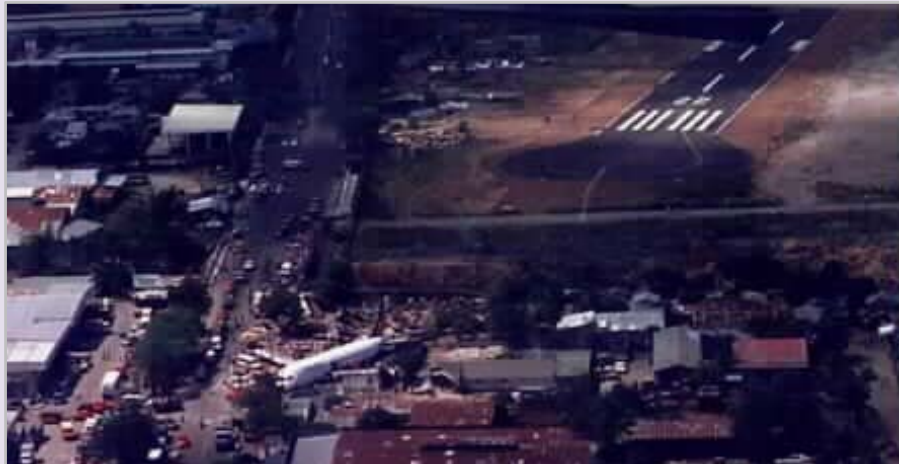
Figure 18: Airbus A320-200 overrun accident, Bacolod Airport, Philippines, 22 March 1998

While there were no on-board fatalities associated with this accident, there were three people on the ground who sustained fatal injuries. The aircraft was damaged beyond economical repair.

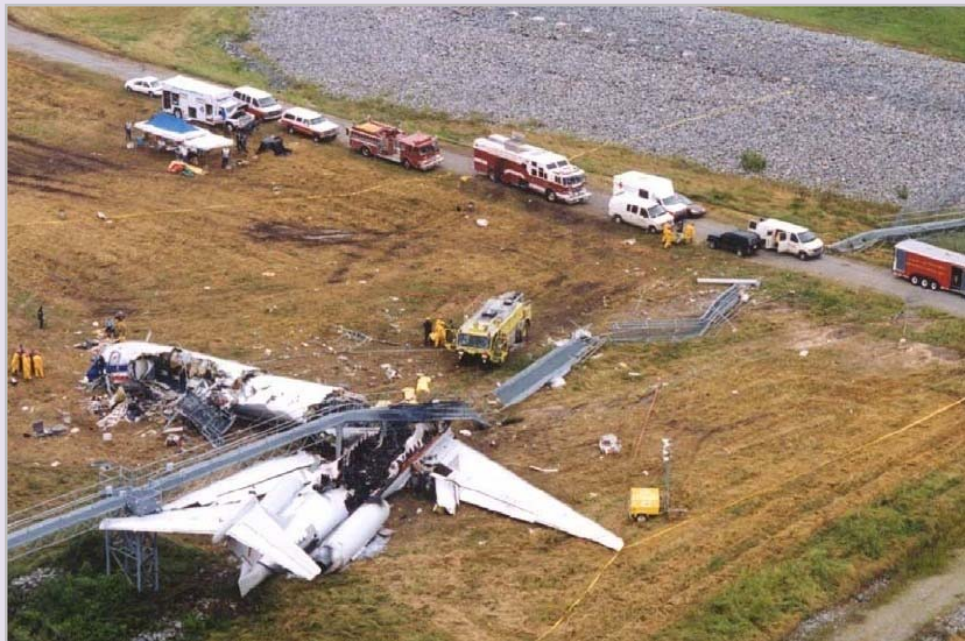
Figure 19: McDonnell Douglas MD-82 overrun accident, Little Rock National Airport, Arkansas, 1 June 1999

On 1 June 1999, a McDonnell Douglas MD-82 overran the runway after landing at Little Rock National Airport, Arkansas. In this accident, task saturation during a late evening approach in severe weather conditions led to a high flight crew workload. Situational stress contributed to the flight crew losing awareness of approach stability (not realising how much runway was being used up by the flare and initial float) and led to delayed crew action in braking after touchdown (e.g. late thrust reverser deployment, ground spoilers not armed). The effects of situational stress allowed the flight crew to place the aircraft in an undesired state in what were already critical weather conditions. The result was a runway overrun.

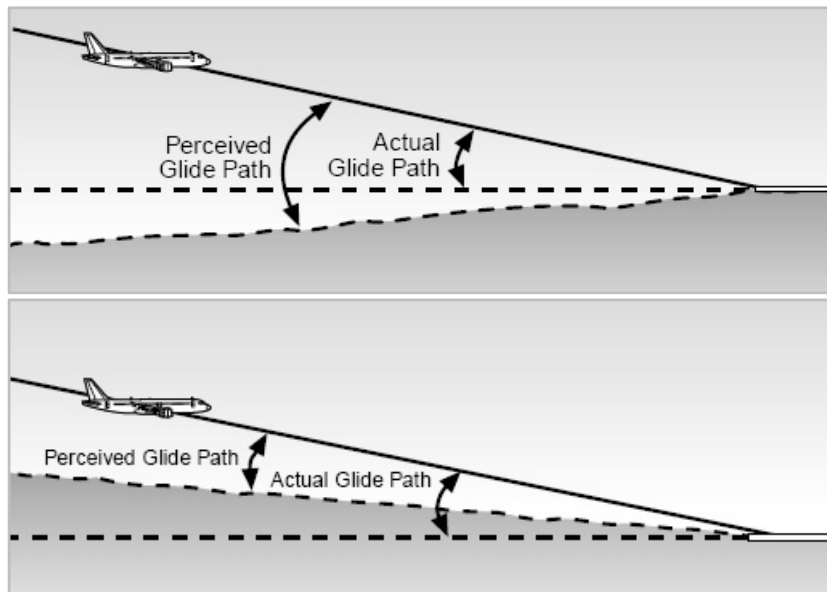
Figure 20: Visual effects caused by different approach path terrain slopes

- ‘Black hole’ effect along the final approach path due to sparse ground lighting at night, creating the illusion of being too high and leading to a low approach.
- Uphill-sloping terrain along the final approach path creating the illusion of being too high. As a result, the flight crew may descend the aircraft to what they perceive to be the correct approach path, placing the aircraft below the desired approach path (Figure 20, top).
- Downhill-sloping terrain along the final approach path, creating the illusion of being too low. Conversely to uphill-sloping terrain, the flight crew may climb the aircraft, leading to a high approach (Figure 20, bottom).

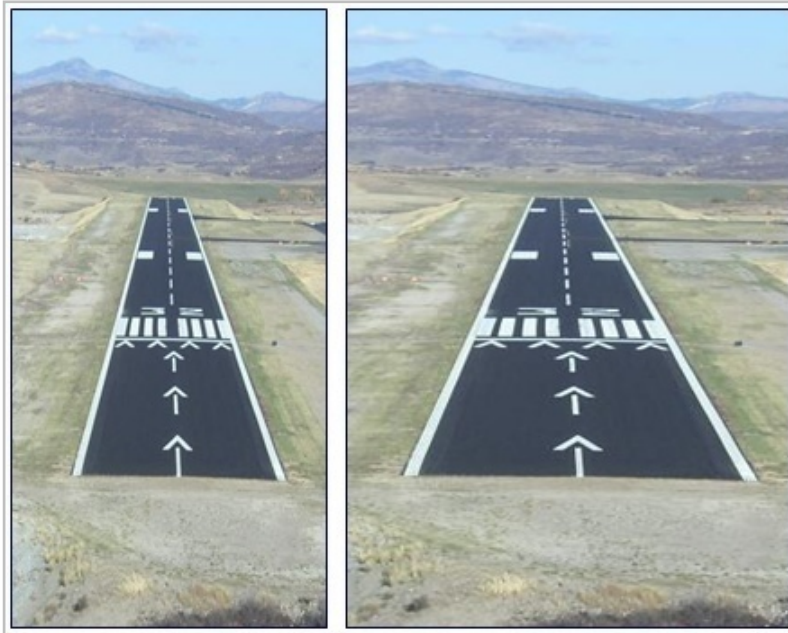
Figure 21: Visual effects caused by different runway aspect ratios

- A high aspect ratio runway (narrow or long) creates the impression of being too high, which can lead to a correction by the flight crew that results in an unstabilised approach that is too low. This increases the risk of undershooting the runway if the approach is not corrected (Figure 21, left).
- A low aspect ratio runway (wide or short) creates the impression of being too low, which can lead to a correction by the flight crew that results in a high unstabilised approach. An extended flare and long landing can occur if the approach is not corrected (Figure 21, right).

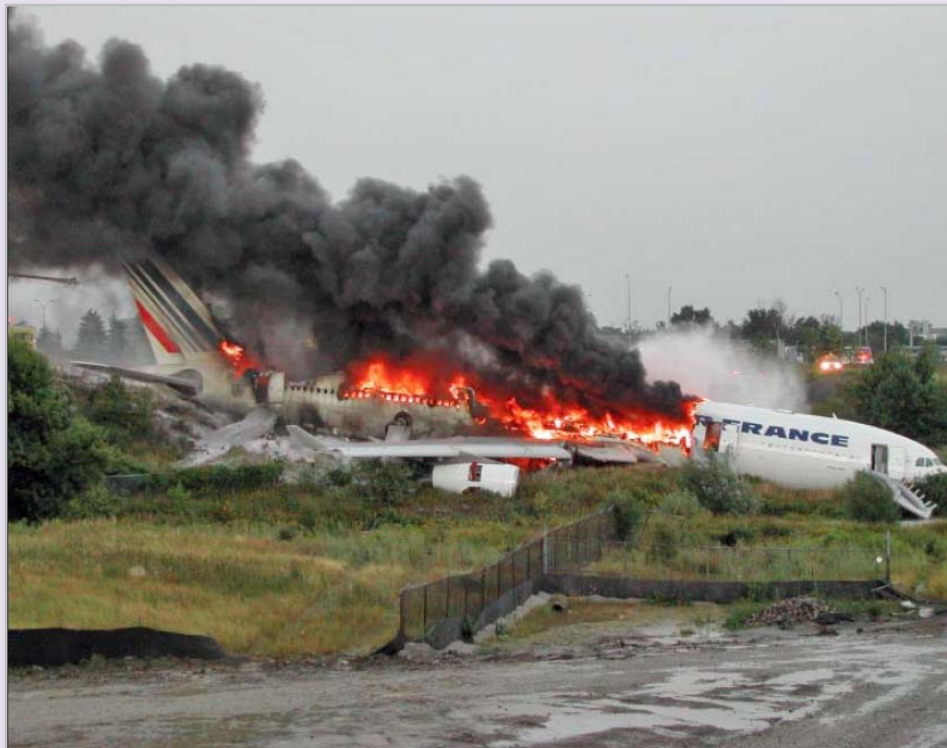
Figure 22: Airbus A340-300 overrun accident, Lester B. Pearson International Airport, Toronto, Ontario, Canada, 2 August 2005

On 2 August 2005, following an instrument landing system (ILS) approach to runway 24L at Lester B. Pearson International Airport, Toronto, Canada, an Airbus A340-300 aircraft landed long and then overran the runway, falling into Etobicoke Creek some 200 m beyond the end of the runway. A fire broke out and the aircraft was destroyed. The accident happened in daylight, but in severe weather conditions. All aircraft occupants were able to evacuate the aircraft before the post-impact fire reached the escape routes, with two flight crew and 10 passengers sustaining serious injuries. No aircraft occupants were fatally injured.

Runway 24L was 9,000 ft (2,744 m) in length. The aircraft touched down about 3,800 ft (1,160 m) beyond the runway threshold. As the aircraft crossed the runway threshold, with the heavy rain, low visibility, lightning and variable winds, the flight crew became overwhelmed by the severe weather conditions and became task saturated, making a normal landing difficult. Because the flight crew were focused on maintaining visual contact with the runway, they did not notice that the wind had shifted from a headwind to a 10 kt tailwind during the flare, significantly increasing the landing distance in the prevailing weather conditions.

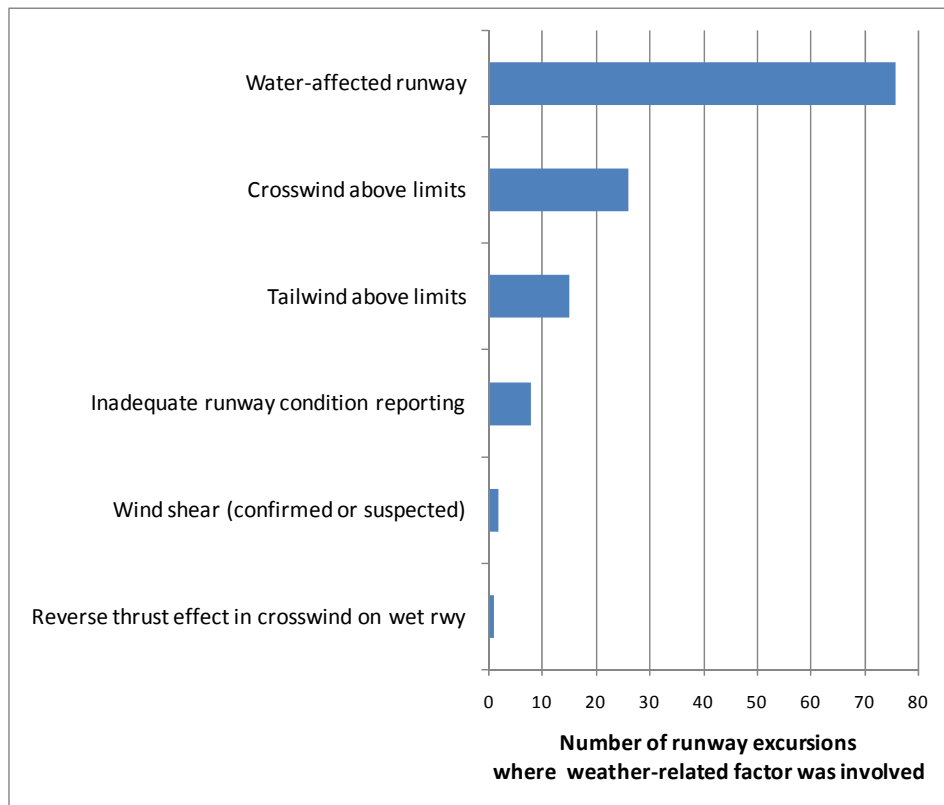
Figure 23: Breakdown of weather-related factors across 29 runway excursions on landing, 1998 to 2007

Figure 23 presents a breakdown of how frequently different types of weather-related factors were involved in the 81 runway excursion accidents. The three most common weather-related issues were:

- a wet or water-affected runway that reduces the friction between the aircraft tyres and the ground, leading to degraded directional control during the landing rollout and lower pedal braking effectiveness;
- landing in a crosswind above the limits published in the standard operating procedures (SOPs) or the manufacturer's aircraft flight manual (AFM); and
- landing in a tailwind above the published limits.

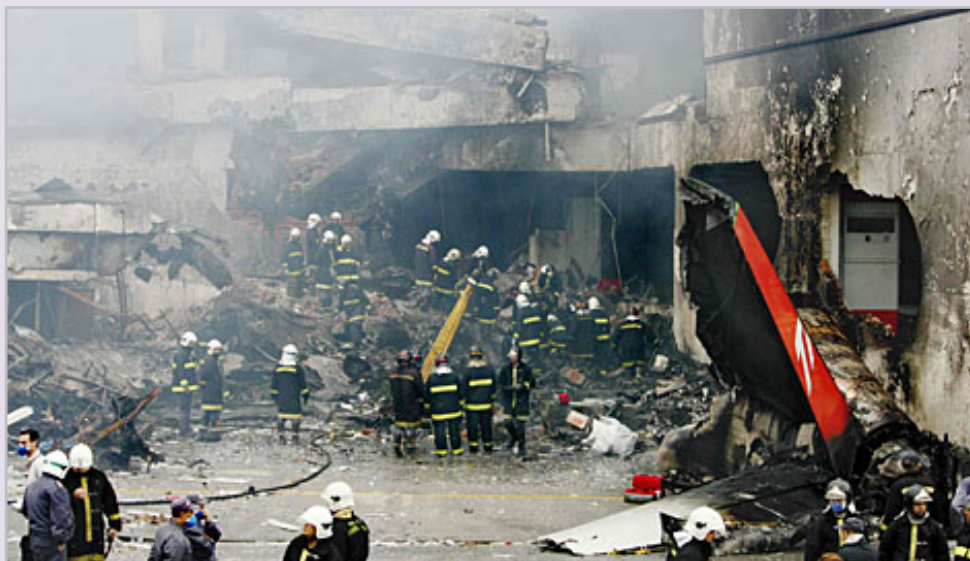
Figure 24: Airbus A320 overrun accident, Congonhas Airport, Sao Paulo, Brazil, 17 July 2007

The tower controller cleared the Airbus A320 to land on runway 35L at Congonhas Airport, Sao Paulo after operating a flight from Porto Alegre, Brazil. The aircraft was destroyed when it overran on landing. After departing the end of the runway, the aircraft veered slightly to the left before going over a steep embankment. It became airborne as the ground fell away beneath it, flew over a major road, and impacted a TAM Express cargo building on the far side of the road at a speed of 94 kts. A fire broke out that destroyed both the aircraft and the building. All 187 crew and passengers on board and 12 people on the ground were fatally injured.

The runway conditions at the time of the accident were 'wet and slippery', and the wind was reported from 330 degrees at 8 kts. Runway 35L had an asphalt surface and had recently been resurfaced; however, it was not grooved at the time. The accident happened in darkness (1850 local time). Runway 35L had a published landing distance of 1,879 m at the time of the accident.

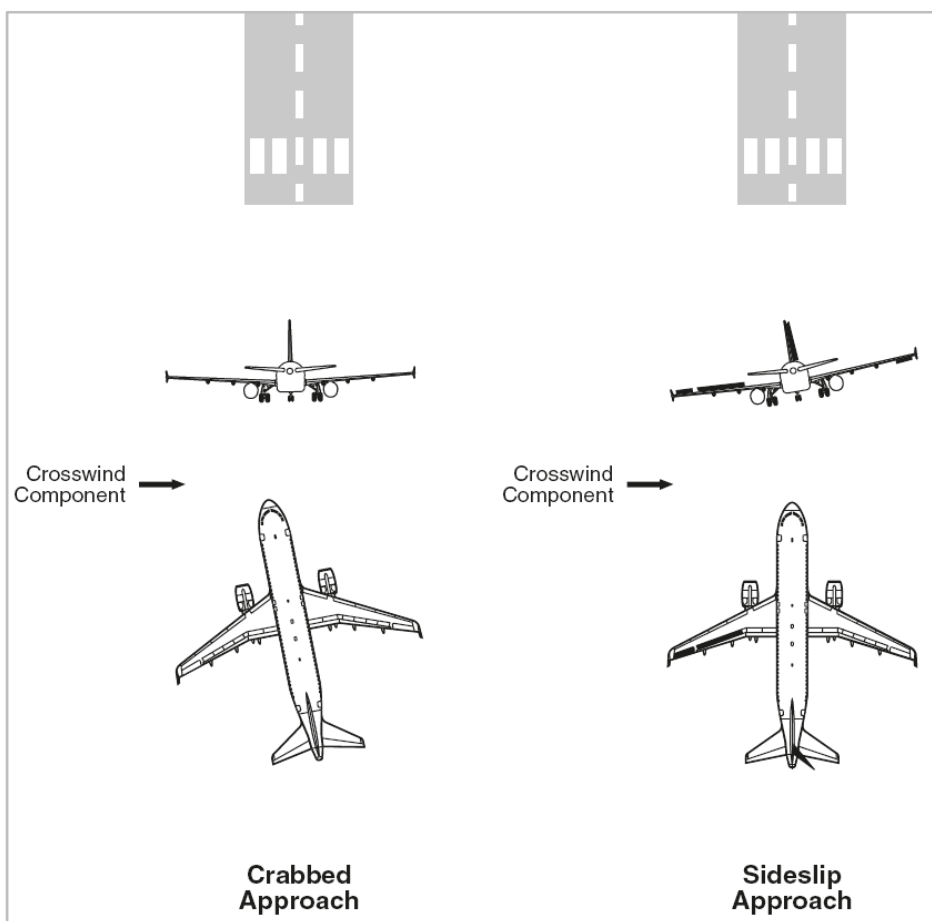
Figure 25: Crabbed and sideslip (de-crab) approaches in crosswind conditions

Incorrect crosswind approach techniques can be a factor in veer-offs, as they can lead to an unbalanced approach. Drifting during the transition from a wings-level crosswind approach (crabbed) to a steady-sideslip crosswind approach, or failing to transition from a wings-level approach to a steady-sideslip approach (de-crab) when landing in strong crosswind conditions can increase the risk of runway excursions (Figure 25) (FSF, 2000d).

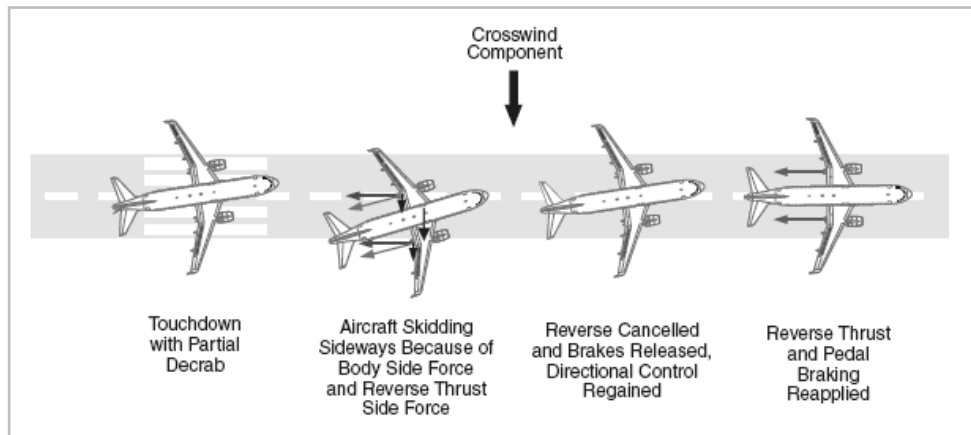
Figure 26: Recovery from a skid caused by crosswind and reverse thrust side forces

¹⁷ See Figure 26 on page 66 for a description of crabbing.

To safely decelerate the aircraft in a crosswind, a combination of into-wind aileron and opposite rudder should be used in conjunction with differential braking to provide directional control and return the aircraft to the centreline. Reverse thrust and normal braking can then be used to decelerate the aircraft (Figure 26) (TSB, 2007).

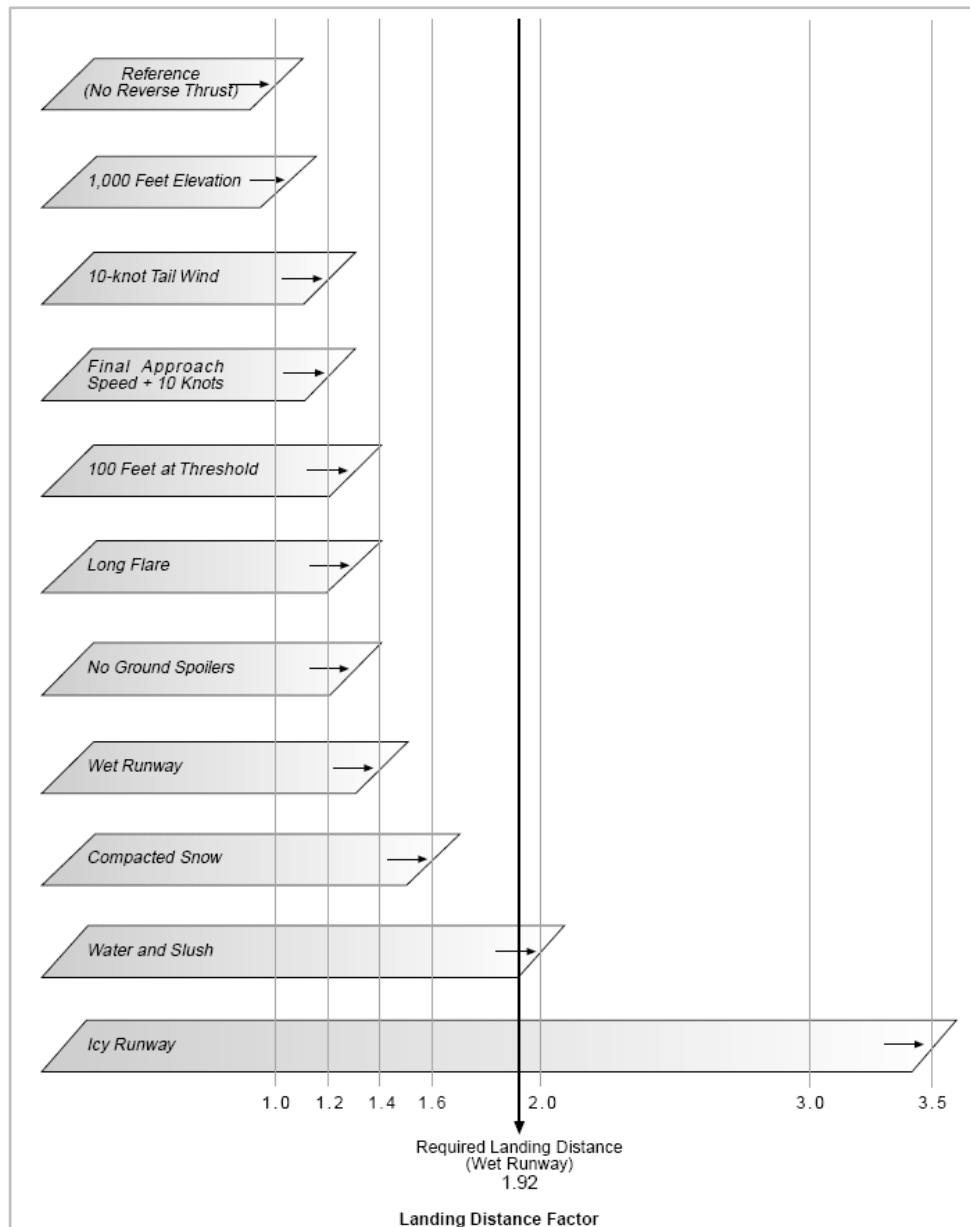
Figure 27: Landing distance factors affecting rollout length

Figure 27 shows how some common flight crew technique and decision-related, flight crew performance-related, systems-related, and weather-related factors, affect typical landing rollout lengths. The effects of ice, snow and high-altitude runways are not specifically discussed in this report as they generally do not apply to Australian air operations; however, Figure 27 provides an indication of the relative impact of those operating conditions on runway rollout length.

If several factors are combined (e.g. a long landing in wet conditions with ground spoilers not armed), the increase in landing distance is cumulative.

When developing SOPs to calculate required landing distances, it is important for operators and flight crews to be aware that the unfactored landing distances provided in the manufacturer-supplied aircraft flight manual (AFM) reflects landing performance in test conditions as flown by test pilots. The FAA FAR Parts 23.75 and 25.195, require manufacturers to quote these distances in the AFM, and specify the required flight test conditions to evaluate these distances. These landing distances are calculated by test pilots in ideal conditions, and are not representative of normal flight operations. Landing distances on water-affected runways quoted in the AFM are generally extrapolated from landing lengths in dry conditions, rather than performing test landings in actual wet conditions (Ranganathan, 2006). Because of this, the FAA recommends that SOPs and flight crews use either factored landing distances (Figure 27), or add a safety margin to the unfactored
