ATSB TRANSPORT SAFETY REPORT
Aviation Research and Analysis Report – AR-2008-018(1)
Final

Runway excursions

Part 1: A worldwide review of commercial jet aircraft runway excursions

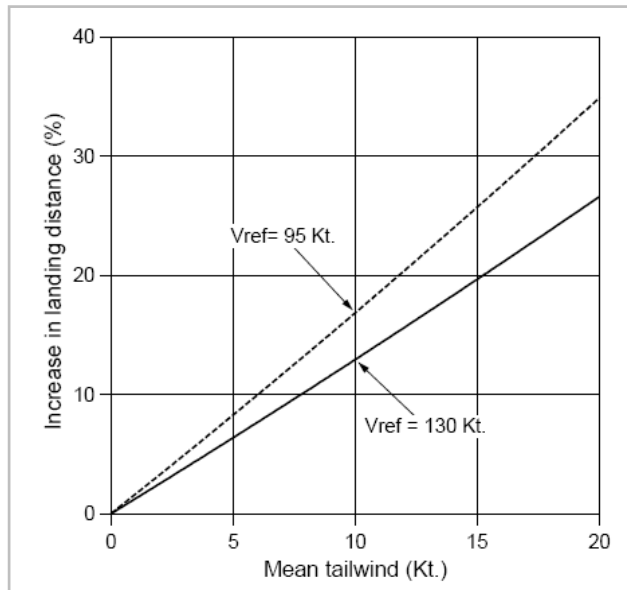
Figure 28: Effect of tailwinds on landing rollout length at different approach speeds

As previously discussed, tailwinds increase approach speeds, and increase the runway length required to stop the aircraft. Figure 28 shows how landing in tailwinds above the standard 10 kt limit increases rollout length and the relative effect during normal airspeed approaches compared with fast approaches.

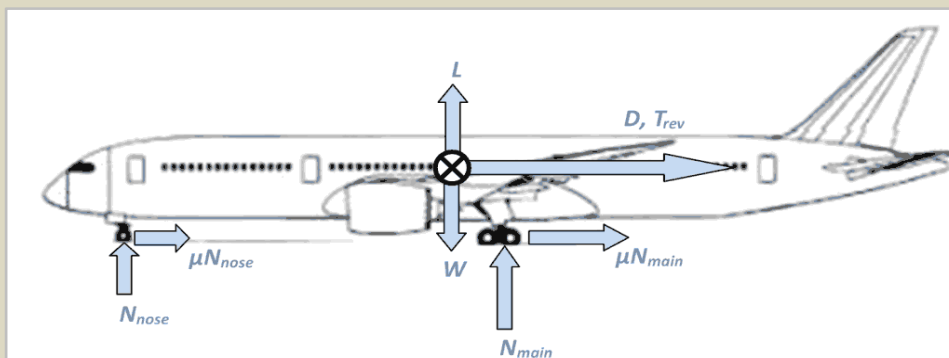
Figure 29: Major aircraft forces during landing

When the aircraft touches down, the weight of the aircraft is distributed across the nose and main wheels, creating a reaction force with the ground (N). At this point, the aircraft is still travelling at speed, and aerodynamic drag (D) provides most of the deceleration force to slow the aircraft down during the landing roll. Reverse thrust (T_{REV}) is also used for part of the landing rollout to provide further deceleration. At slower ground speeds, rolling drag from the wheels and brakes (μN) is the main stopping force. Lift (L) and aircraft weight (W) effect how much rolling drag is available.

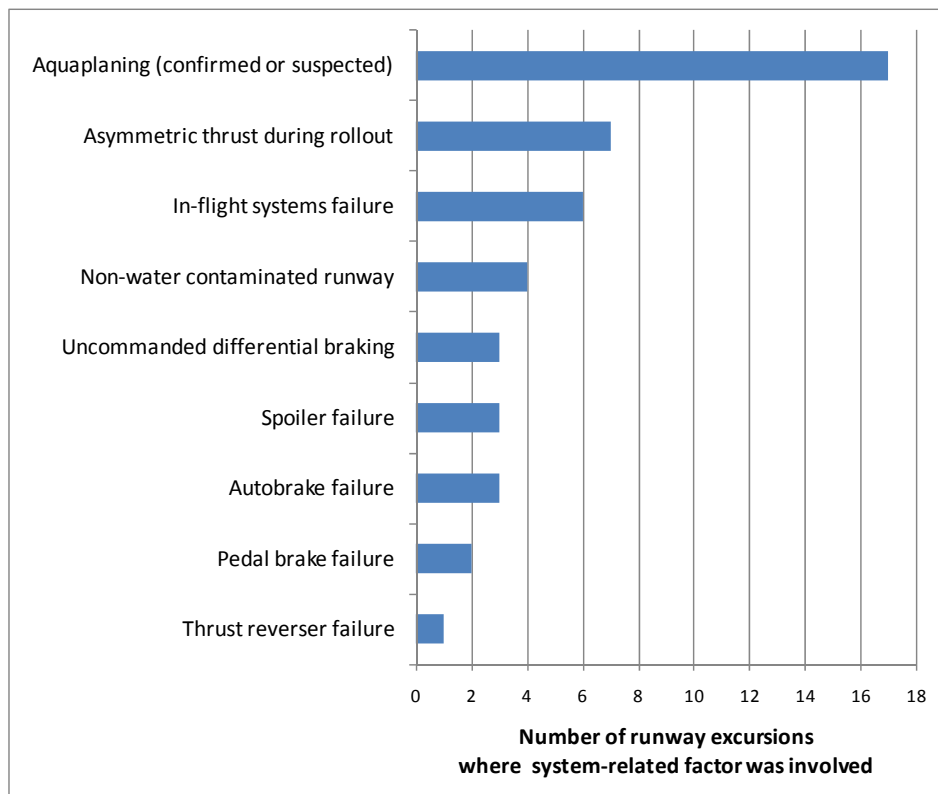
Figure 30: Breakdown of systems-related factors across 29 runway excursions on landing, 1998 to 2007

Figure 30 presents a breakdown of how frequently different types of systems-related factors were involved in the 40 runway excursion accidents where these types of contributing factors were identified. Suspected or confirmed aquaplaning was the dominant systems-related factor involved in overruns and veer-offs, accounting for almost half (43 per cent) of the probable systems-related contributing factors. Failures or unexpected operation of braking devices (such as spoilers and thrust reversers) were also significant.

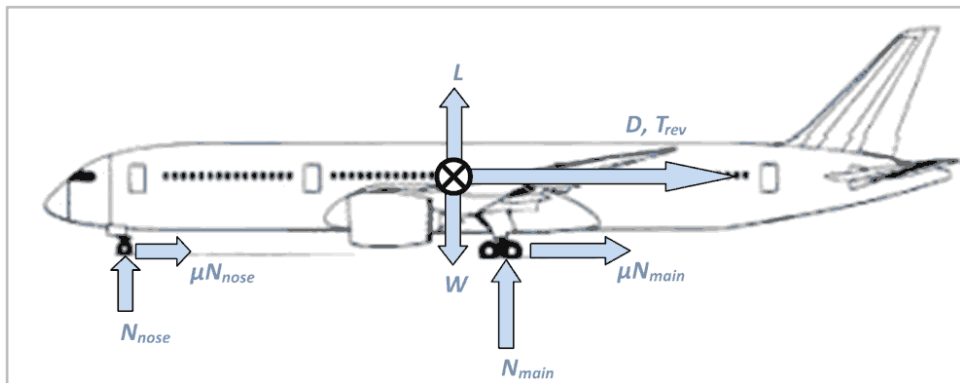
Figure G.1: Boeing 787-8 free body diagram (landing rollout)

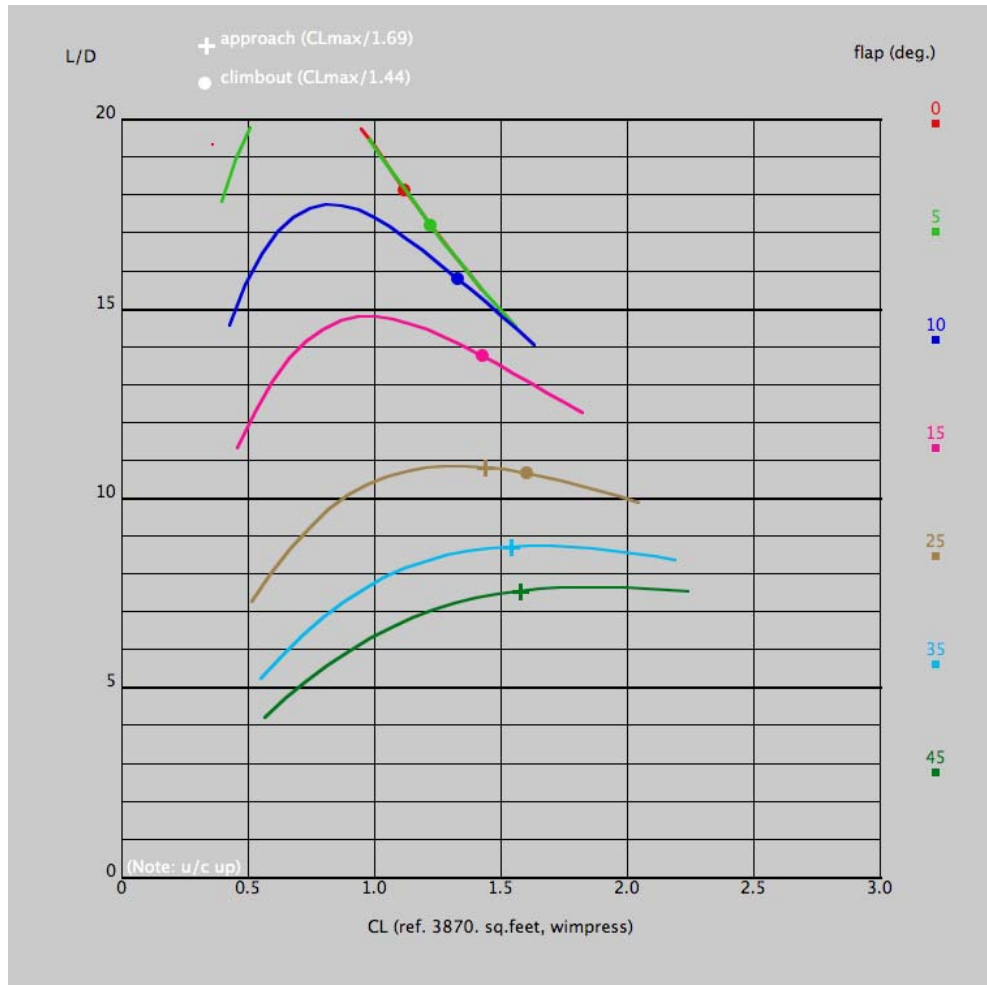
Figure G.2: Boeing 787-8 lift-drag curve (approach, flaps deployed, gear up)
